Norfolk Historic Buildings Group

Newsletter

Number forty-four

Autumn 2021

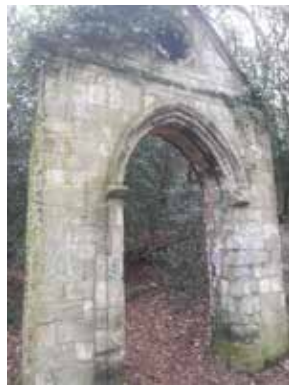
The original photo

One of the photos from the “lockdown walks” section in the last newsletter, submitted by Chris Ash, was of part of a ruin now in the grounds of County Hall.

NHBMG member Owen Thompson, who is a specialist on the eighteenth- and nineteenth-century history of the Cathedral, explains that the Infirmary at the Cathedral was demolished in 1804 and some of the stones were sold to Philip Meadows Martineau who owned the Bracondale estate that now houses County Hall.

Some of the stones that he purchased were built into a “chapel”, part of which now constitutes the ruin in the original photograph.

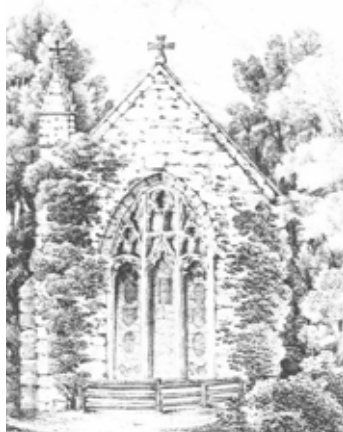
Ladbroke drew the chapel in 1820 entitled “The Priory”.

Ladbroke's drawing of the chapel, entitled "The Priory"

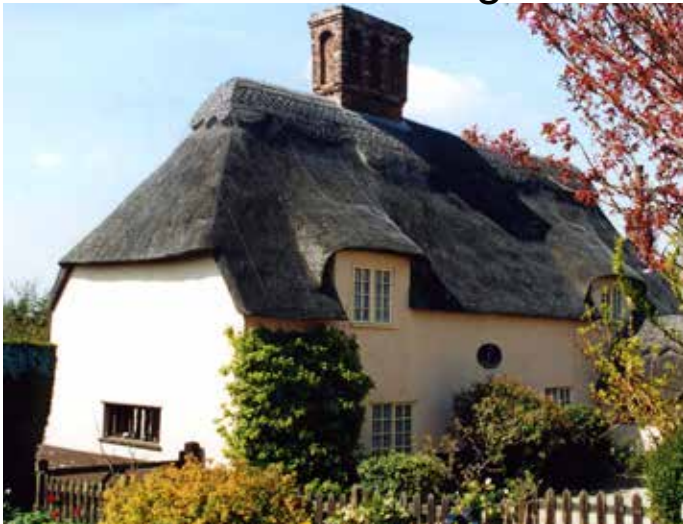
Lime Tree Cottage

- Three Cells - Parlour, Hall, Services.
- Stairs in Service bay - later set added next to stack for second unit.
- Entrance in cross-passage position next to hall/service wall.
- No corridor upstairs (only house in Hempnall)

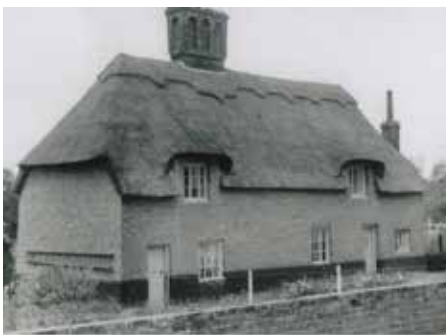
- brick skin to whole house using common flettons (before 1950s)
- Thatched with half-hipped ends
- Three sets of purlins, middle row clasped by collars - top row to support short rail supporting the top of the hipped-end rafters
- Headroom in hall raised by raising the ceiling
- Divided into two units in the eighteenth century.
- Cutting through of tie-beams has not resulted in the spreading of the building due to the dovetail joints made with the door frames.

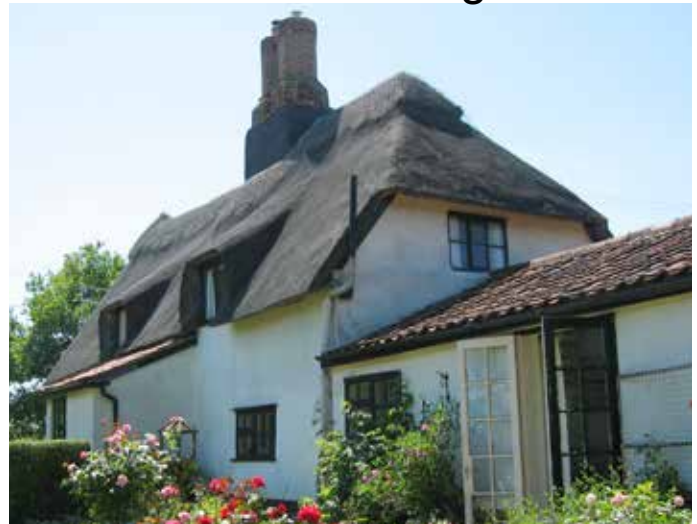
Poacher's Cottage

- Two cells plus single storey lean-to services (replaced by axial ridged extension in the nineteenth century).
- Stairs next to stack - later set added for second unit in parlour.
- Entrance in cross-passage position next to hall/service wall, altered to lobby entry in 1959.
- Upstairs corridor created in 1959

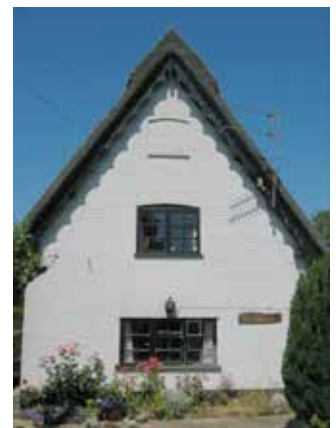
Lime Tree Cottage

- brick wrap-round gable to south end
- Thatched with one half-hipped end
- One row of purlins at north end, two rows in south section.
- No access to roofspace determine whether third row of purlins exists
- Headroom in parlour raised by excavating the floor to below external ground level
- Divided into two units in the seventeenth or eighteenth century.
- Two central tie beams have been cut through for access with no corresponding remedial action. This has resulted in the house spreading by 15cm (6in) in the centre.

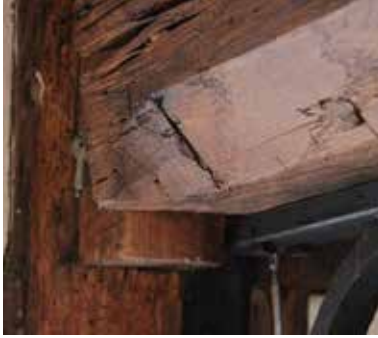
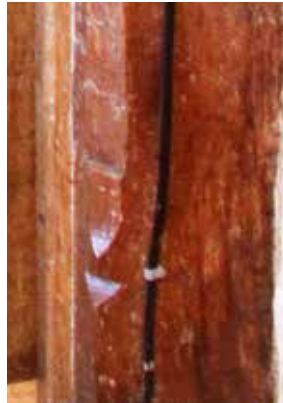
- Timber throughout is plain and undecorated, except for two inserted doorframes between chambers which may have been inserted when the Vicar lived in the property in the 1640s.
- Slightly scalloped shield stops to principal joist chamfers in hall, plain shields elsewhere, except for the two doorframes between upstairs chambers which have elongated shield stops with a deep notch.

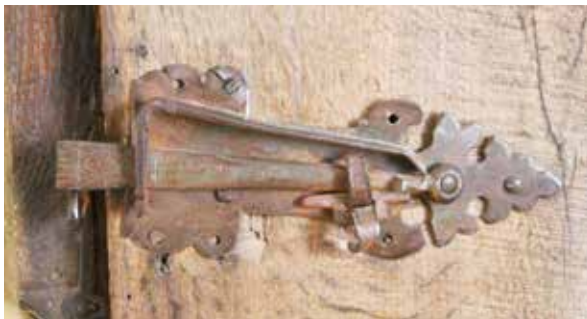
- Upmarket door fittings - early latch (dated examples in Linda Halls book of 1616 and 1647) - this one may extend that further back. Saltire cross over the door/frame gap.
- Strap hinges with fancy plates.

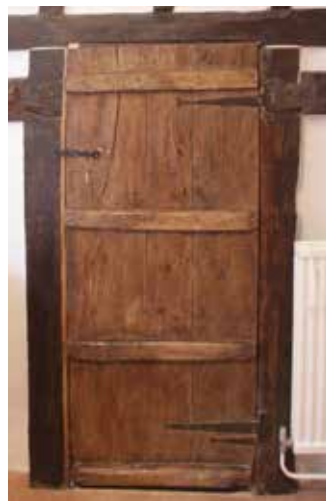
- Battened, three-plank, creased doors upstairs, also showing the strengthening dovetails on the cut-through tie beam.

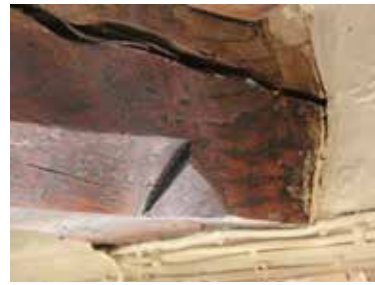
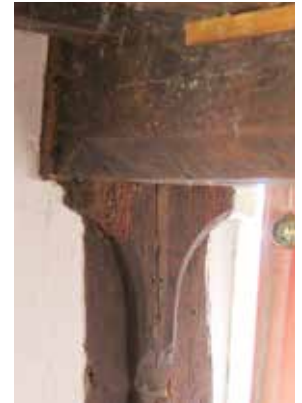
- Timber in north end of good quality - common joists chamfered and stopped. In the southern half, the timber is insect damaged and is of elm
- Plain shield stops to the hall chamfers, but cut at a different angle to the chamfer itself. Plain shield stops to parlour principal joist chamfers, cut normally.
- Fancy shaped supports on the storey posts to support the principal joist in the parlour.

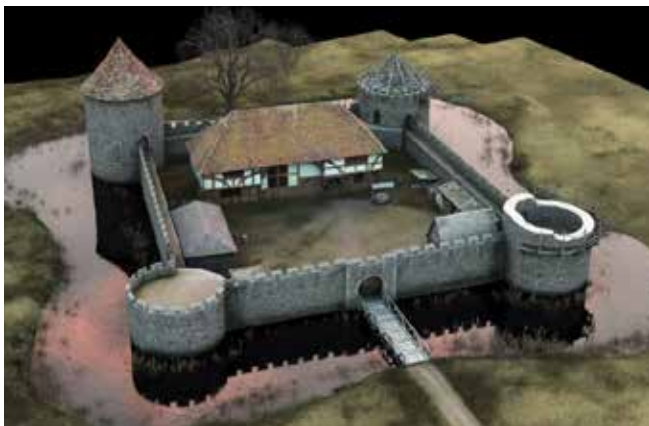
The Pastons Footprints project has been examining Gresham Castle, one of the buildings owned by the Pastons. Gresham Castle is now an isolated site in the middle of a field, on private land and hence normally inaccessible. Early in 2020 the Paston Footprints Team carried out some drone photography. However, even in the winter the vegetation is considerable and obscured the walls and the moat, but a LIDAR scan revealed the walls and the round towers. This enabled the Team to be accurate about the location of the Castle and its overall size. The walls of the castle were probably never completed. Further research suggested that there was a manor house within the Castle site. Models of the house can be viewed on the website with views linking the Castle to the local church and village.

Reconstruction of Gresham Castle from the thisispaston website noted above

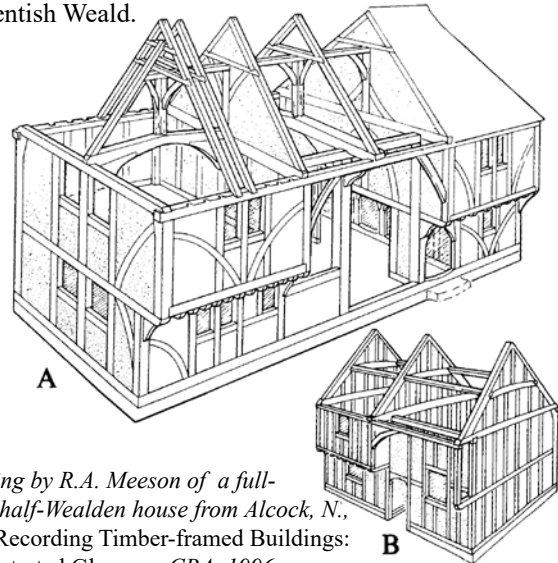
Drawing by R.A. Meeson of a full- and a half-Wealden house from Alcock, N., et al, Recording Timber-framed Buildings: an Illustrated Glossary, CBA, 1996,

The term 'Wealden house' describes a distinctive medieval structural type, found most commonly in Kent and Sussex, for which the name 'recessed-hall house' is also used. In its full form it is characterised by having an open hall flanked by floored, jettied end bays, all under a single roof. Because the wall plate is aligned with the front walls of the end bays, it 'flies' over the hall, where it is usually braced from the corner posts of the end bays, giving the distinctive 'recessed' hall appearance. The term 'Wealden' apparently came into use among members of the Vernacular Architecture Group in the 1950s, reflecting the concentration of examples in the Kentish Weald.

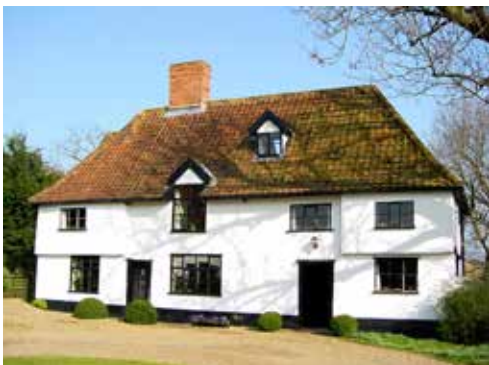
Yew Tree Farmhouse, Forncett

Also surveyed by NHBG and reported in NHBG Journal 4 in 2009 - *The Tacolneston Project: A study of historic buildings in the Claylands of South Norfolk* on pages 128-132. It can be seen on the NHBG archive as NF00025.

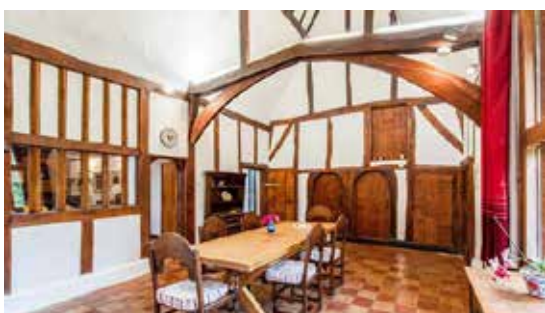
The historic Great Hall now serves as the principal room and the two original doors into the service rooms can be seen in the centre of the wall, with the later door just above them when the hall was floored over (now removed).

The main hall at Brett's Manors

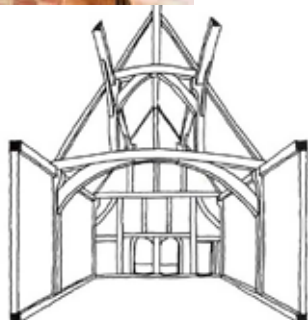
This drawing of the Queen post over the Open Hall and service doors in its original form is taken from *The English Medieval Roof: Crownpost to Kingpost*, edited by John Walker, Essex Historic Buildings Group, 2011.

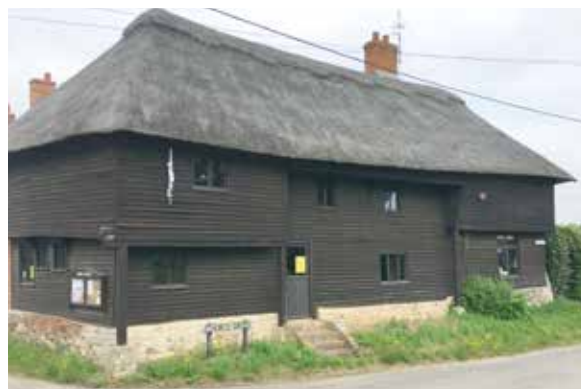
Wooden House, West Acre. photo: Les Scott

Recorded on the NHER as: Flint, stone and clunch rubble plinth, weather-boarded timber frame, thatched roof, central two-storey open-hall, recessed on the south front, Two storey east and west wings with jettied first floors Casements replaced and jetties supported with C20 posts and lintel. All external wooden details from 1982 renovation. Steeply pitched thatched roof with off axis stack, Interior: 2 storey open hall, Central arch-braced tie beam. Crown post roof. Stack, largely rebuilt 1982.

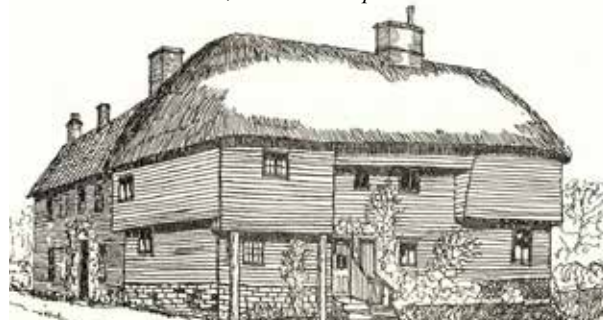
The Wooden House as drawn by H.W.Messent in 1928 in his book *The Old Cottages and Farmhouses of Norfolk*, p143.

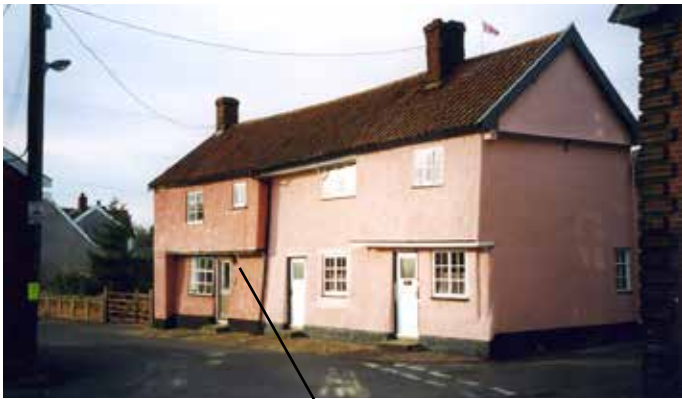
Corner Cottage & Crawford's, New Buckenham

under-shot crosspassage bracket

The framing of the jetties is unusual as the very short jetty joists are tenoned into the last of the longitudinal ceiling joists, a feature also found at Yew Tree Farm. The former under-shot crosspassage is defined by two brackets below the jetty.

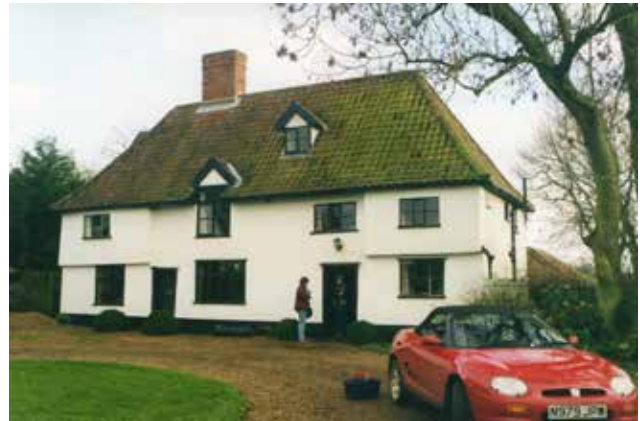
Yew Tree Farm, Forncett St. Mary

The long splayed scarf joints used in the wall plates suggest an early, probably fourteenth century, date. The roof has been altered and the crown posts have gone (during restoration the opportune arrival of the householder saved the crown post purlin from the builder's bonfire), but most of the original structure is present, including the jetty framing as seen in Crawford's and Corner Cottage.

The spectacular service door spandrels have yet to be interpreted. Unfortunately, no viable timbers were found for dendro analysis.

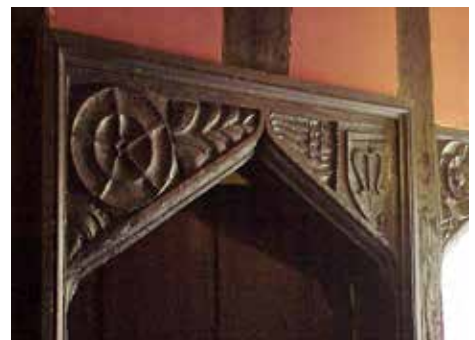
*right:
the service-door
spandrels*

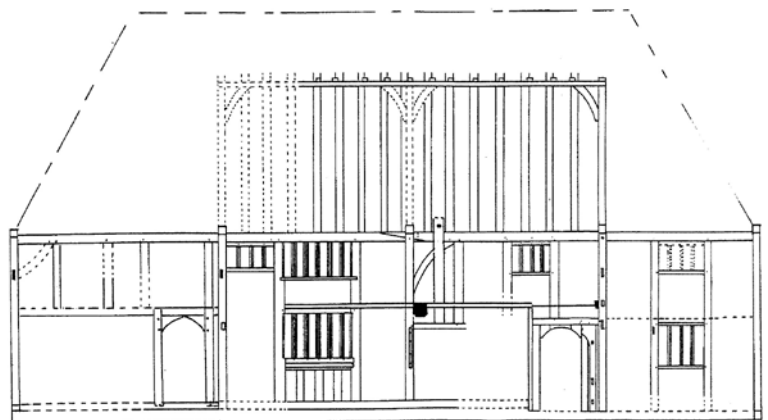
*below:
Yew Tree Farmhouse
- the west elevation
showing the long
splayed scarf joint in
the centre of the
wall plate*

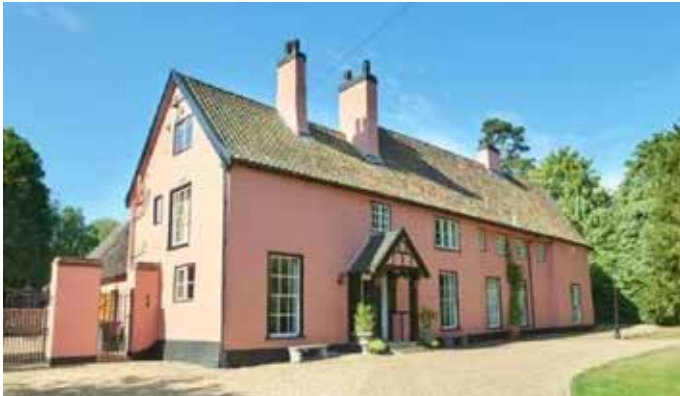
The Old Rectory, Long Stratton

This magnificent building masquerades as a routine Georgian product, but the steep roof and central recessed bay are obvious clues to what is found within. Here the roof structure largely survives, including the central truss over the formerly open hall. It can be seen in the section drawn below that the truss is central to the narrower central bay rather than to the roof as a whole. The truss has a cranked tie beam with giant arched braces under the surviving moulded crown post. The form of these mouldings suggests a mid-fifteenth century date.

No viable timbers were found for dendro analysis. Our account of this outstanding house has not been published except as an insert in a NHBG Newsletter and in the NHBG Archive (see sidebar below), and is lodged with the HER at Gressenhall.

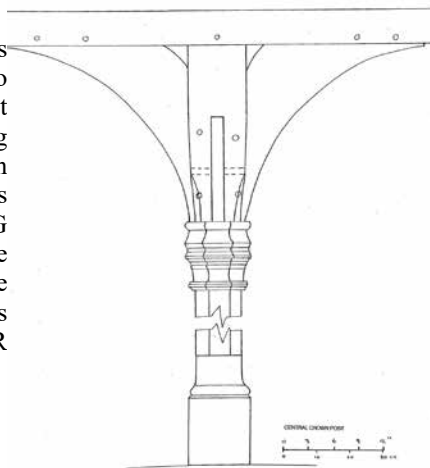
details of the moulding of the central crown post

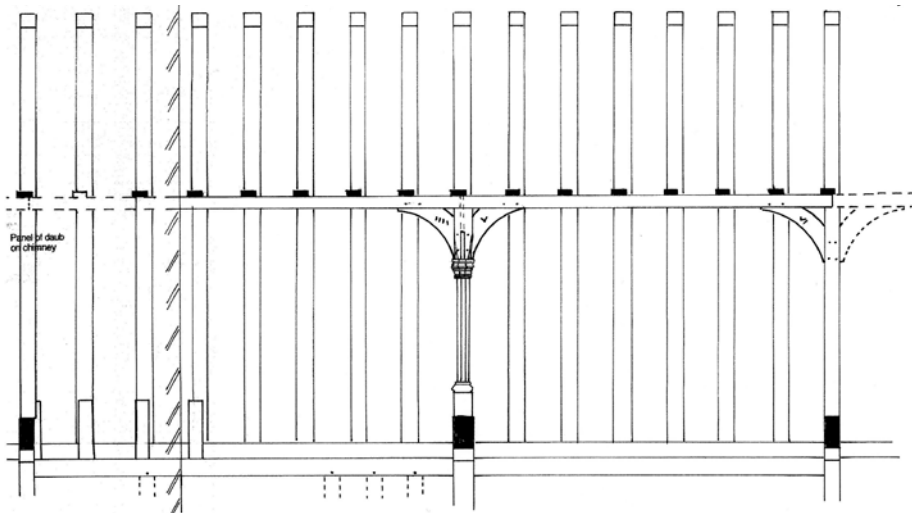
The Old Rectory - Long section of the north face of the hall

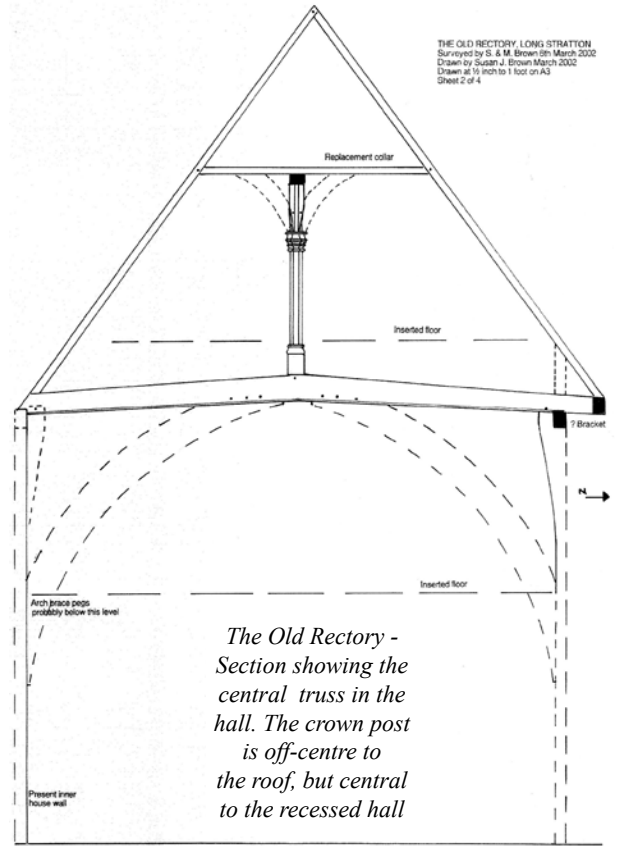
The Old Rectory - Section showing the central truss in the hall. The crown post is off-centre to the roof, but central to the recessed hall

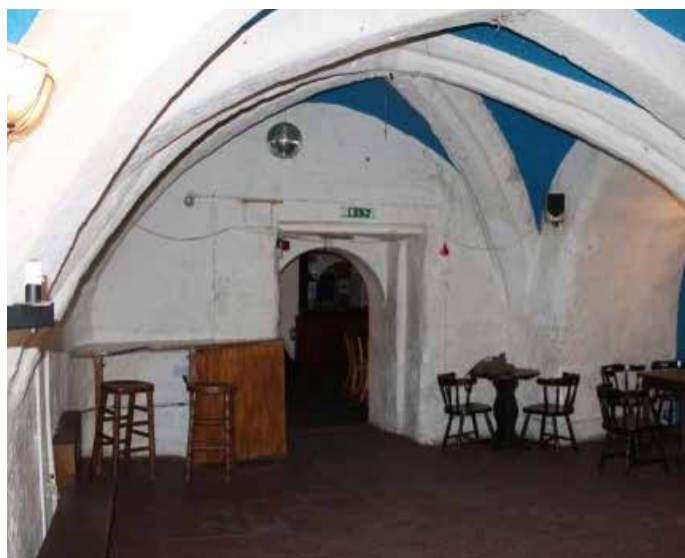
Ribbed undercrofts are usually based on rectangular bays with diagonal ribs and a lateral rib between bays. The majority of rib vaulted undercrofts have quadripartite ribs, which means that each bay has 2 pairs of diagonal ribs dividing the vault into 4 triangular cells.

*Ribbed vaulting beneath 17 Tombland
(all photos: Terry George)*

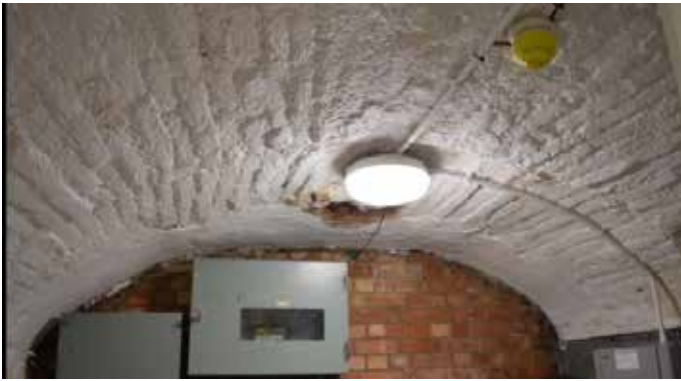
Barrel vaults are semi-circular vaults and are found with or without lateral ribs.

A barrel vault at 21 Bedford Street

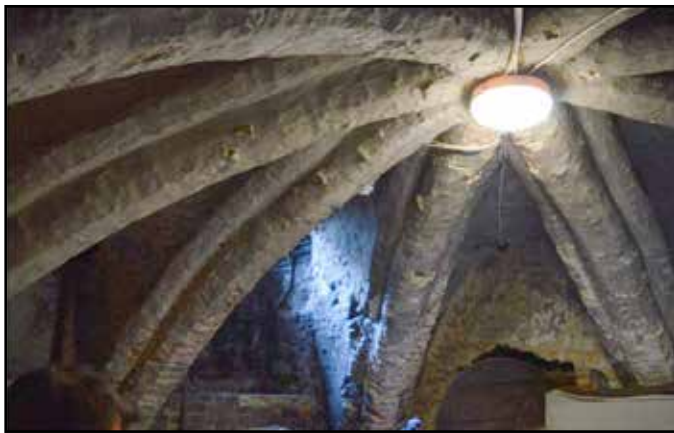
Most undercrofts lacked adornment and, because of the narrowness of their entrance, can probably only have been used for domestic storage. However, the vaulting in some is quite elaborate, unnecessary for mere storage use. Several of the chambers under the Bridewell have octopartite ribs.

Elaborate octopartite vaulting at Bridewell

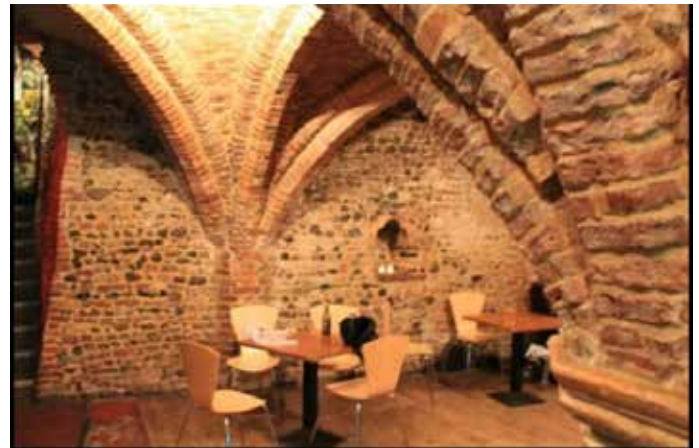
This could be a means of showing off a merchant's wealth or because the undercroft was used for display purposes and designed to impress. The undercroft beneath Bedford's has a central pillar which allows for 4 bays of high vaulting.

Central pillar and ribbed vaulting at Bedfords, enlarging the space available

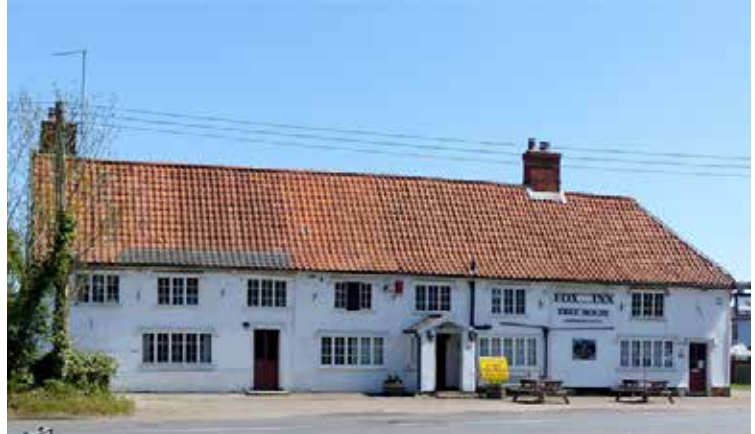
The Fox Inn incorporates the substantial remains of a timber-framed house dating from the early to mid-16th century. It was built as an unjettied house of two storeys, probably on a tripartite plan. Of the original building a two-bay ground-floor hall, heated by a hearth in a high-end smoke bay to the south, and an in-line, axially divided service bay to the north can be identified. The parlour to the south is also timber-framed but appears to have been substantially rebuilt in the 18th century. The roof survives above the hall and service bay. It is of queen-post form with plank-like curved braces up to the collars and to the rather slight side-purlins. The roof was originally hipped at the north end and may have been hipped to the south as well. In the 18th century the building was extended northwards to provide a substantial kitchen, and the hipped north end to the roof was replaced by a gable.

A modern single-storey porch probably corresponds roughly with the original cross-passage. The principal stack is towards the south end of the building and occupies a former smoke bay; an additional chimney serves the kitchen to the north. Various additions to the rear, which have been cut into the valley side, include some work in clay lump.

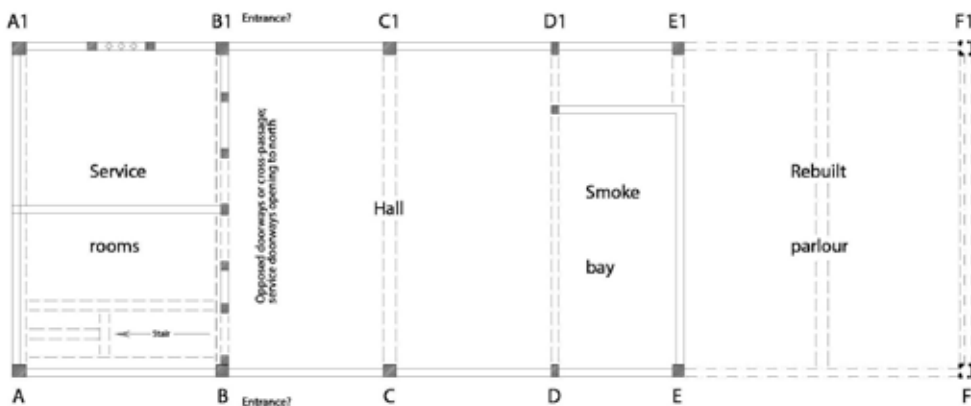
Diagrammatic reconstruction of the original ground-floor plan

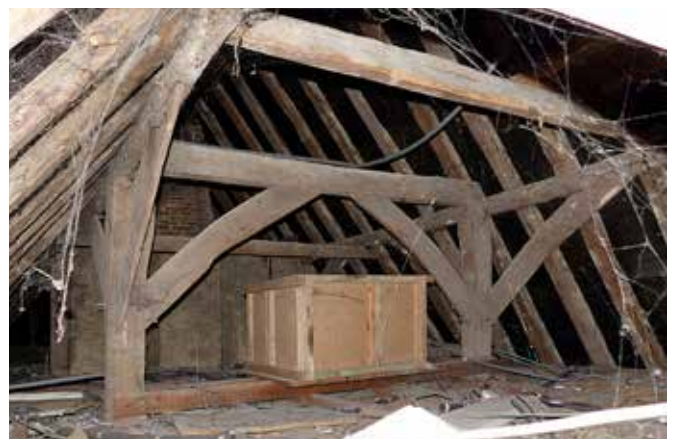
One of the substantial queen-post roof trusses

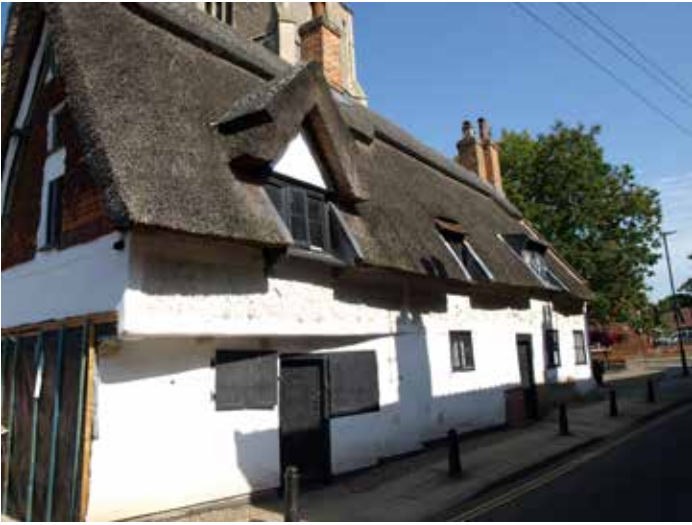
Bishop Bonner's Cottage, Dereham

This row of three seventeenth-century cottages stand on Withburga Lane in Dereham close to the parish church. They are owned by the Town Council who pay for their upkeep and are used by the Dereham Heritage Trust as the town museum. Their survival is a miracle, due probably to the remarkable, very elaborate pargetting on the front wall. This report has really helped the Trust to understand these cottages.

This building seems to have been created by joining together two pre-existing timber-framed structures. The southern (jettied) building may be earlier in date than the northern (unjettied) one. The presence of rafter seatings on the jetty plate may indicate an earlier stage of the building when it was unjettied and of only one storey, presumably open to the roof. A subsequent raising of the roof and construction of the jetty might explain why a tie beam has been re-used on its side as the axial principal joist at the south end.

This end is also narrower, resulting in the eccentric ground plan as the two were combined. The combination of the jetty to the south with the unjettied wider north building also resulted in the progressive elimination of the jetty as the east wall was brought forward, perhaps literally by moving the jetty plate, to make the join between the buildings. It seems that the plan was to create a continuous surface for the upper wall, no doubt to take

the late seventeenth-century pargetting which is the building's distinguishing characteristic. During the 2021 building works the south end wall was exposed. All the timbers (cill, studs and girt) were seen to be modern replacements. A reinforcing girt having been bolted to the original girt all evidence of the earlier structure has been obscured.

When the two ends were joined they were both single-celled, one-and-a-half storey, with queen-post roofs. They lack any precise dating features, like most vernacular buildings; the queen-post roof may be found in Norfolk up to the seventeenth century, or even later.

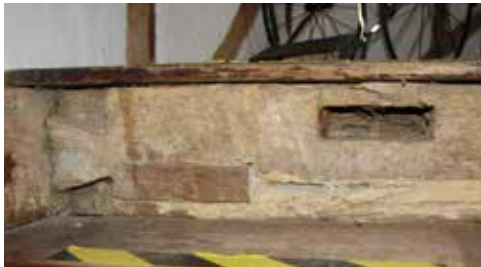
The re-used tie beam, on its side, showing the characteristic half-dovetail joint to the left that enabled it to grip the wall plate in its original location

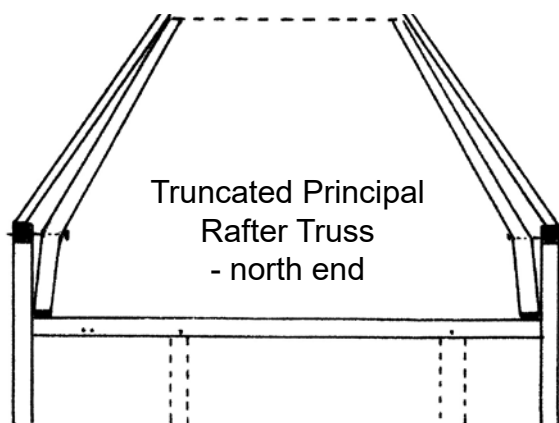
Truncated Principal Rafter Truss - north end

It was interesting to find that the 'upper crucks' noted in the building by earlier writers are in fact examples of the intriguing truncated principal-rafter trusses. We first identified these during our survey of Walsingham (NHBG Journal No. 6) and have subsequently found them in a number of other north Norfolk buildings. Previously they had only been found in the North East with one example in Lincolnshire. They consist of naturally curved or cranked timbers standing often on their own footing timber on top of a tie beam, scribed round the side purlins and joined at the top by a collar that caps them so that they do not reach to the roof apex, i.e. they are truncated. They seem to have been inserted to provide stability to existing roofs or as alternating trusses with queen posts. They are characteristic of the roof designs used in houses of the seventeenth century in the Low Countries, suggesting that this is an example of continental influence on local practice through the links of maritime trade. Their presence in both of the end buildings here suggests that they were inserted at or soon after the time of their combination.

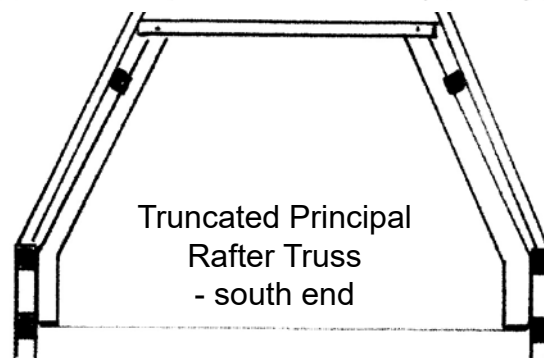
Truncated Principal Rafter Truss - south end

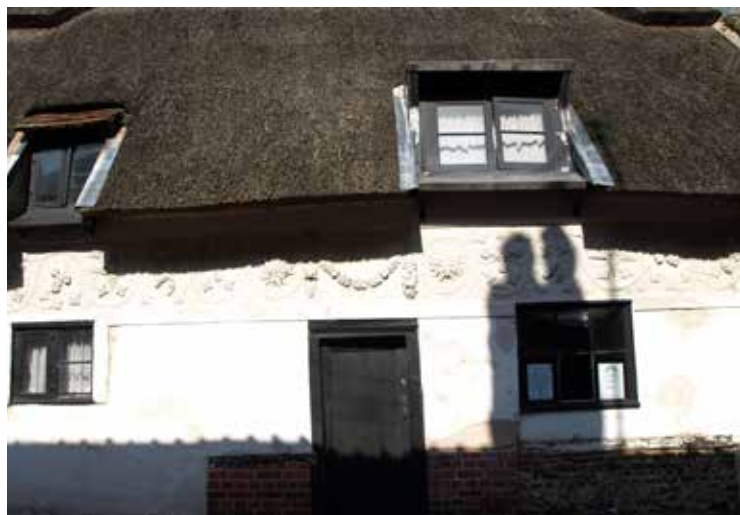
The elaborate pargetting on the front wall

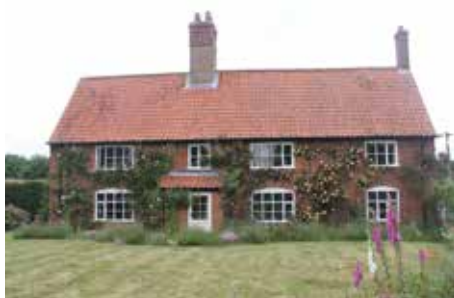
Elmerdale Farmhouse, Saxthorpe

A tripartite house of around 1625-1650 was built with two full storeys and attic, set well back from the road. It was originally timber framed with a wrap-round brick gable, the front wall was replaced in brick and the service end rebuilt in brick with a flint gable wall.

Behind it sits a separate building at an eccentric angle, probably a dairy, which was incorporated into the house by a linking range in the early nineteenth century, as part of a larger phase of internal alterations and improvements. These seem to have created a house where servants quarters and access was kept separate from the main rooms.

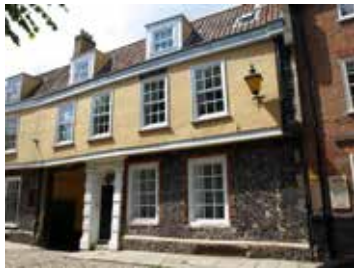
36 Elm Hill, Norwich

Taken with No. 34 this house forms part of a large sixteenth-century building. It is jettied to the street and with a large central cart entrance also jettied to the rear, which leads down to the river.

It is no doubt a replacement for a building destroyed in the fire of 1507. The street façade has been re-fenestrated in Georgian style and the division into two properties is marked by two Georgian door cases.

Extending under the street for a short distance is a low undercroft with a four-centred arch, which may be a survival from a preceding medieval building. Internally the most striking feature is the principal joist of the first floor which extends across the building for a length of nearly 25 feet. If the top floor is a secondary structure this would be the original tie beam. The third floor features some re-used historic timbers and some modern, with a shallow roof angle, and is likely to be a recent construction.

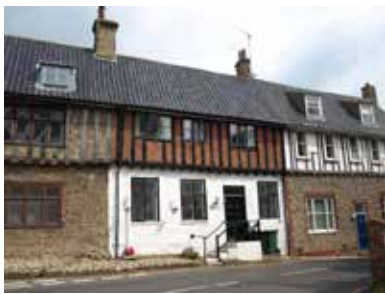
5. Common Place, Walsingham

This house has a solid ground floor wall under a close-studded jetty to the front and with widely-spaced studding to the rear, like its neighbours numbers 4 & 6. It seems with them to form part of a larger building, with a continuous jetty.

The extensions to the rear (north) of the house and the present stair are not part of the original structure. The chimney stack, in an original bay, to the west and the party wall with number 4 may be of the same eighteenth-century date as the impressive panelling of the ground floor western room.

On the upper floor all of the partition walls and the western wall, (with the stack), are later insertions; only the eastern party wall to number 6 is part of the original building. This implies that the upper floor, from the eastern party wall through to the studded partition wall in number 4, was a single open room with a series of tie beams and their arch braces supporting an open roof of undecorated queen-post trusses. Evidence of this remains in the roof of number 4 and of number 5. The section to the west of the studded partition in number 4 may be the stair bay giving access to the first floor chamber by a former doorway to Common Place.

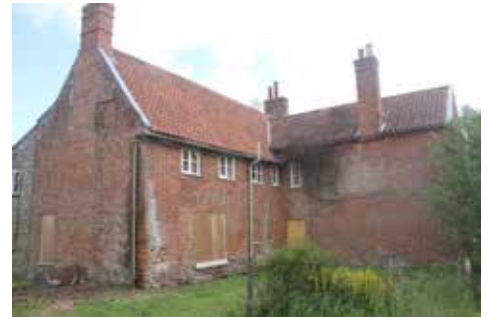
Bintry Farmhouse, Itteringham

This house has an L-shaped floorplan which started as a one-and-a-half storey, two-celled, range of around 1600. It appears to have had a central chimney stack and was built in English-bond brickwork, much

of which was replaced in around 1700 when the stack was replaced by at least one of the gable-end stacks and the walling rebuilt in Flemish bond which was raised by about 20 courses. One of the ground floor rooms still has part of the original steeply-chamfered crossed principal joists.

There is a steep staircase to the attic within the original chimney bay and what appears to have been a (now removed) dormer window in the south roof plane to light this part.

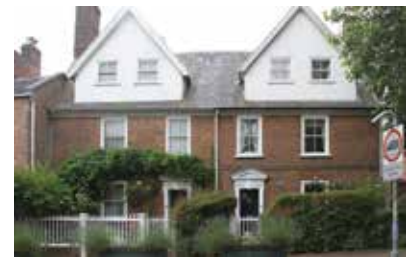
62 Bracondale, Norwich

No 62 is the right-hand half of a pair of semi-detached houses opposite the top of King Street. Both halves are of two full storeys plus attic with a red brick front wall

built in Flemish Bond of narrow bricks, with a chimney stack at each end. It is built on a wider flint plinth with two courses of brick coping. The four sash windows have sash boxes set flush with the wall surface, but the sashes themselves are later replacements with horns. The windows are set symmetrically, but not equally spaced. Immediately below them are the two doors with pediments, shouldered architraves and key blocks set proud, with two similar windows to those above but which have rubbed-brick, skew-back arches.

The two large rendered dormers stretch almost the entire length of each half of the house, they are formed in a roof with two side purlins.

There are several vertical joins in the brickwork of the front wall of both 62 and 64 indicating once-larger window openings that pre-date the eighteenth-century sash windows. A history report prepared for the owners discovered occupants back to 1670, and it refers to this pair of houses as a "rare surviving example for Norwich of a pair of 'double-dwellers'". Nothing we found is likely to indicate an earlier date.
