Norfolk Historic Buildings Group

Number forty-one
Autumn 2020

The Old Vicarage, Hempnall: a detective story

Ian Hinton

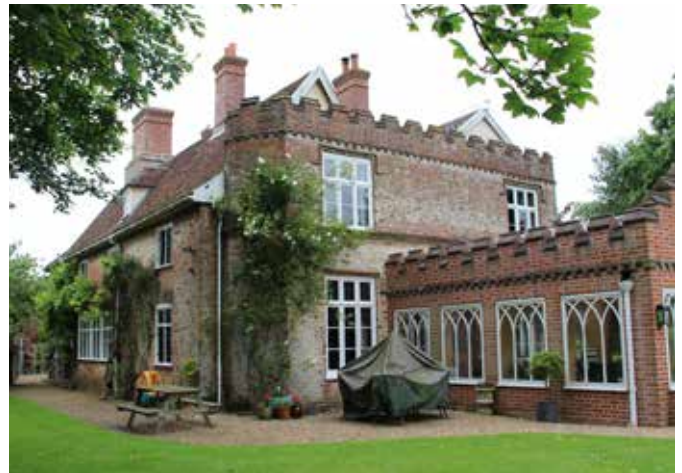
The Old Vicarage from the south-west

C17/18 house, plastered timber frame, fronted in brick in C18. Steep pegtile roof with gabled ends. Large brick chimney stack near west end. Two storeys and attic. One hipped dormer. Four window range. Two-light casements with leafed panes, ground floor large multi-light window. West end doorway with Gibbs surround and panelled door. Gabled wing at rear forming L-shaped plan, plastered. East side faced in brick with embattled parapet, two storeys, three bays, central four-centred arch alcove on ground floor.

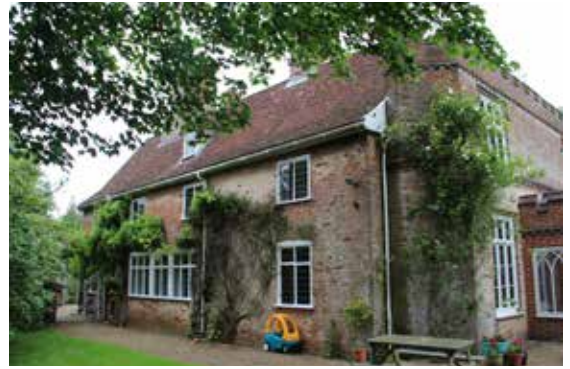
The Old Vicarage - phase 1 from the south-east

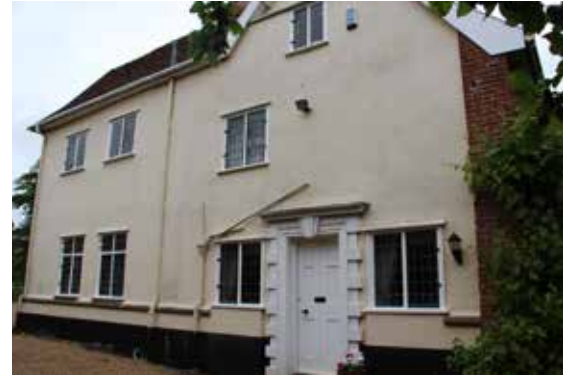
phases 1 and 2? from the south-west

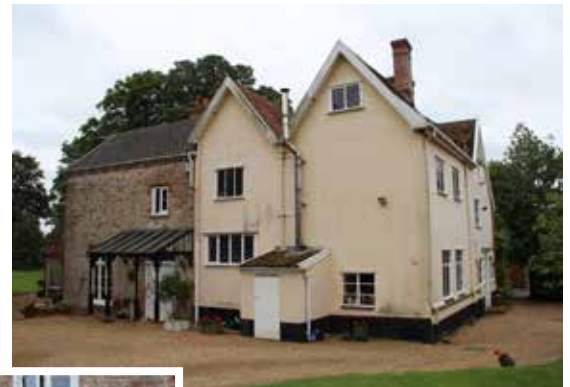
*above:
phases 2? and 3 from the north-west*

The shallow eastern extension (phase 4) has angled corners, a large central alcove, platband, and crenellated parapet above a full dentil strip and windows that match the northern elevation.

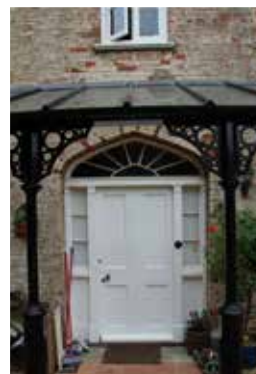
*left:
The Georgian entrance
in phase 3*

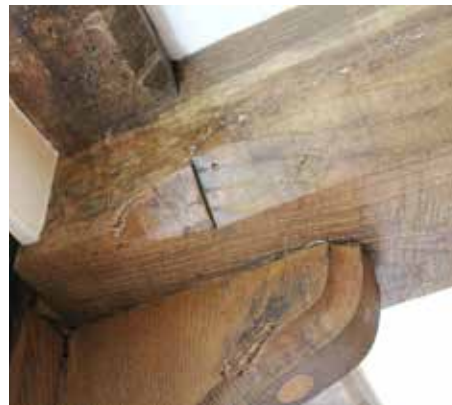
The applied additional supports at either end of the principal joist in the hall

The transverse principal joist in the hall has a plain chamfer with simple shield stops. It appears to be tenoned-in at both ends and is additionally supported at both ends by applied brackets. The sill beam is missing on the southern, external, wall where much of the wall is occupied by a later window. On the north wall, the sill is cut through by three doorways, two of which are blocked. The top and right side of the westernmost blocked doorway is comprised of two pieces of the same reused elaborately-moulded timber, possibly a principal joist, which has a chamfer consisting of a double ogee separated by a central raised section, all terminated at one end by a bar, large leaf stop and nick. The bays in this room are unequal - 2.27 and 3.24m. This room has a stack at both ends, although there is no visible hearth in the eastern stack.

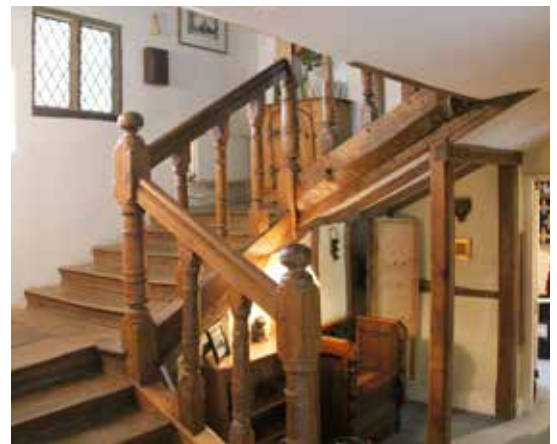
above: inserted seventeenth-century oak staircase

The central extension to the north of the first range (phase 2?) houses an inserted oak staircase, the turned balusters of which are seated on a crudely chamfered rail applied to the staircase string to make it wide enough to house them; six half flights continue to the attic.

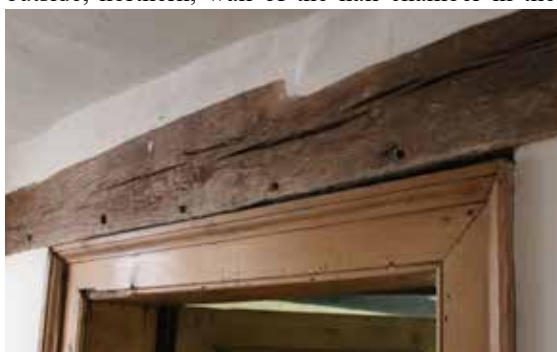
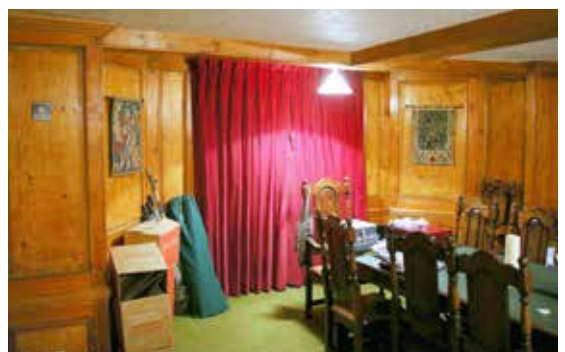
Five pegholes in the wallplate for a window in the hall chamber (seen from the outside)

below: the pine-panelled eastern room (phase 1+)

The room on the other side of this stack (phase 1+) is panelled entirely in pine hiding all constructional details, including a pine-clad axial principal joist. A detailed inspection is required to assess whether the panelling was made for this room or was re-used from elsewhere.

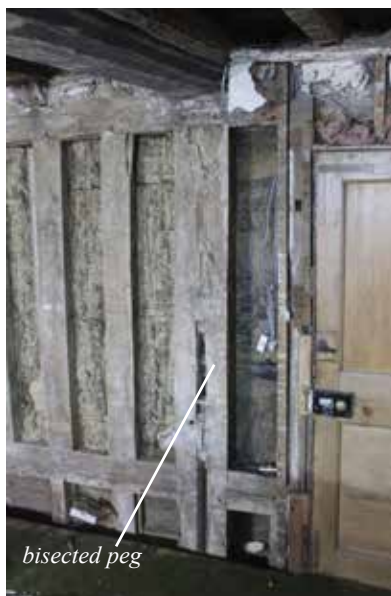
bisected peg

The north wall showing the large-section studs, set close together, the large mortice and the peg bisected during the hacking-back process

In the north wall, this revealed several new aspects. The degraded timber originally seen from the outside only - which was thought to be an outshut connection - was actually part of the substantial midrail; the studs in this wall were of considerable scantling, such that the gaps between them were no larger than the width of the studs, and they were fully pegged. The storey posts on both sides of the hall contained long mortices approximately 1m long overall and 5cm wide. In the southern wall the timber framing sits inside the brick cladding above the mid-rail. The jowls and surface of both storey posts had been significantly hacked back prior to the plastering out of the room, to the extent that one of the brace pegs in the northern storey post has been bisected and two others are now very close to the face of the post.

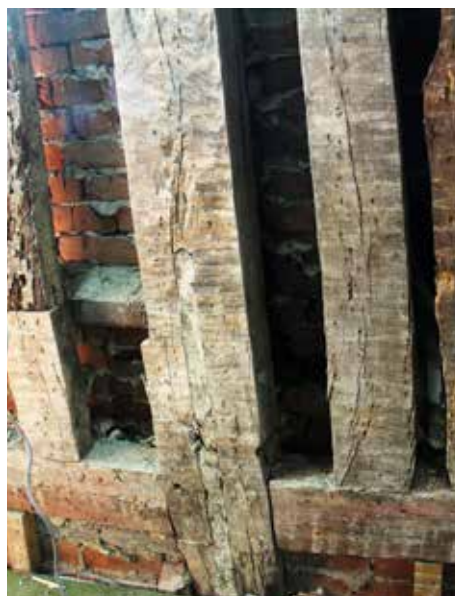
The south wall, showing the matching large mortice (plaster-filled) and the remnants of red colouring on the mid rail

Remnants of red colouring were found on the inner surface of the mid rail of the south wall.

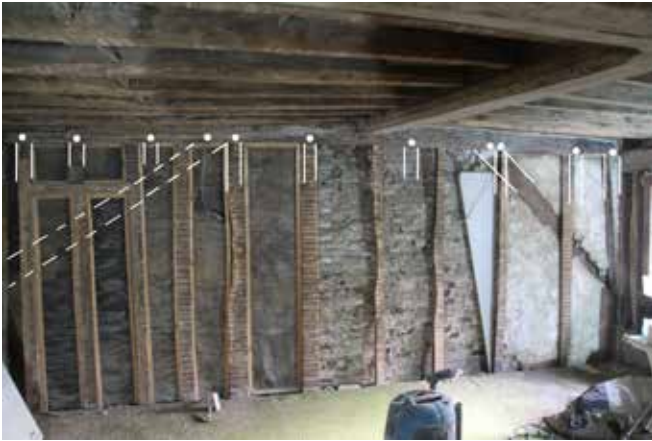
hall chamber east wall showing the lack of a mid-rail and the inserted doorway with different stud spacings from the originals.

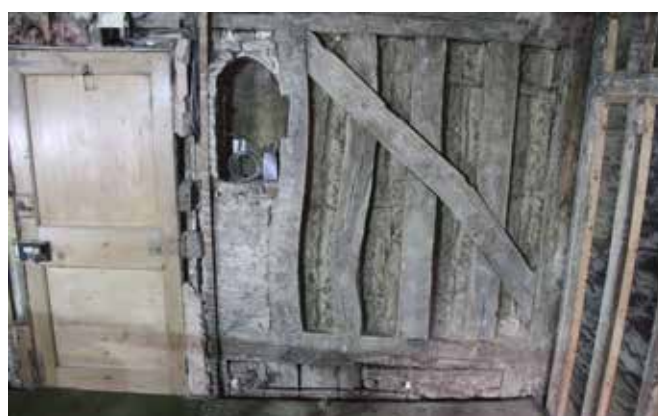
the eastern end of the hall chamber north wall (part of elevation B previous page) showing the lack of pegholes in the lower edge of the mid-rail, thereby revealing the position of a possible window and the cross-passage door below it.

The odd-shaped niche cut into the brick noggin probably dates from the building of the corridor and stairwell the other side of the wall, as a previous resident of the Vicarage told me that in his time there, this niche was open to the corridor and stair on the other side of the wall (presumably for a night light) rather than open to this chamber.

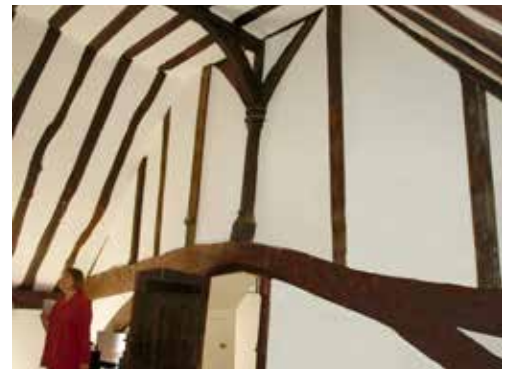
Below: A similar roof at 3-5 Castle Street, Thetford (also awaiting dendro)

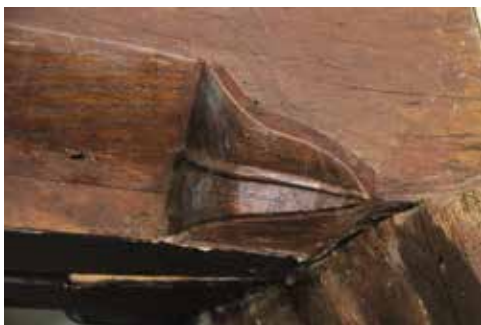
Meadow Farm, Hempnall

Another of the discoveries during the study of Hempnall's houses was the attractive leaf-pattern chamfer-stop in the hall of Meadow Farm. None of us had come across this pattern before.

Since the houses are less than 5km apart, were these unusual stops the work of the same carpenter? If they are, does that mean there are more still to be found?

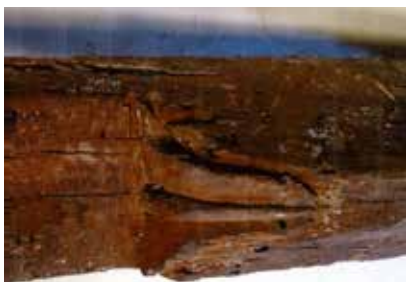
The Old Rectory, Woodton

The Old Rectory in Woodton was also visited for the project at the invitation of the owner Jack Clover, as a result of an appeal placed in the church newsletter. It had a similar arrangement to the Old Vicarage in Hempnall - with a chimney stack at both ends of the Hall. The parlour end of the house had been replaced by a brick-built crosswing in the 1820s and some of the timbers were cut up and re-used below the floor. Having seen the picture of the stop at Meadow Farm in the Journal, Jack has sent the NHBG a photo of a similar stop on one of the re-used timbers in his house (in remarkably good condition, given that has been below a floor for 200 years!). The only difference being the continuation of a diminished chamfer after the stop.

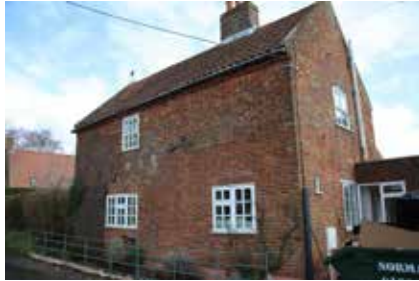
Penfold is a two-celled cottage, originally of just over a single storey, located immediately south of the village green in Aldborough. It has an off-centre axial chimney stack.

The rear (east) wall consisted almost entirely of flint up to the original eaves height. There is a lean-to single-storey extension at the rear.

The front and rear walls have been raised by twenty courses and topped by a two-course dentil strip. The roof ridge was raised by the same amount, with tumbling-in at both front and rear. There are two vertical joins in the front wall – the first, up to the original eaves height, aligns with the centre of the chimney stack and the second is above the left-hand window in the photo above; both are 13½ bricks long (app 3.15m). The brickwork of the remainder of the lower part of the front wall matches that of the eaves-raise. The three-casement window in the front wall has replaced the original door, opposite another in the rear wall, also replaced by a window.

The flint construction of the rear wall and the two rather-odd vertical joins in the front wall pose the question of whether this house was originally all built of flint, perhaps with brick gables, with the front wall replaced in brick at different stages. The burnt headers in the gable ends are often seen in seventeenth-century buildings but can stretch into the eighteenth century. What probably started as a small two-room-with-attic cottage, probably of the late-seventeenth or early-eighteenth century was enlarged and improved in the late-Georgian- or early-Victorian period.

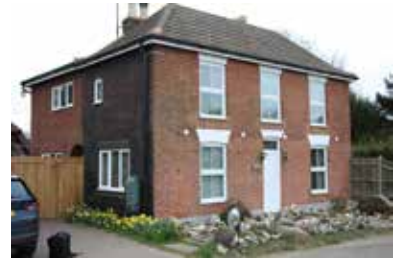
Ivy House has an almost square floorplan, with a two-storey, red-brick front range built on the edge of Somerton common. Behind this are two extensions, the first, to the east, has a rebuilt

east wall in mid-twentieth-century bricks with a blocked opening in older red bricks. The other, western extension is known to have been built in 1969.

The front wall has a central door case with a rectangular fanlight over. This, and the five modern windows, are under skewback arches, rendered over. To the rear is a single-storey outbuilding built in clay lump at an angle to the house and has a thatched roof. It has been subsequently joined to the house. A further thatched outbuilding, built in brick and flint, sits behind the house, again at a slight angle to the house axis.

Ivy House was originally a small single-pile, three-celled, building of two full storeys with two lateral chimney stacks at the rear. The room sizes do not indicate a building of status and the overall design suggests a date of around 1800-1820. There is likely to have been a rear extension, perhaps single storey, replaced by the later extensions.

The clay-lump building is difficult to date; there have been no clay-lump buildings dated before 1790, but its angle to the house, and that of the other outbuilding, could indicate that they were both built at a different time from the house, possibly before. Taken together, the buildings suggest a small farmstead built on the edge of the common in about 1800, extended not long afterwards and again in the mid-twentieth century. It is possible that the current house is a replacement for an older building on the site.

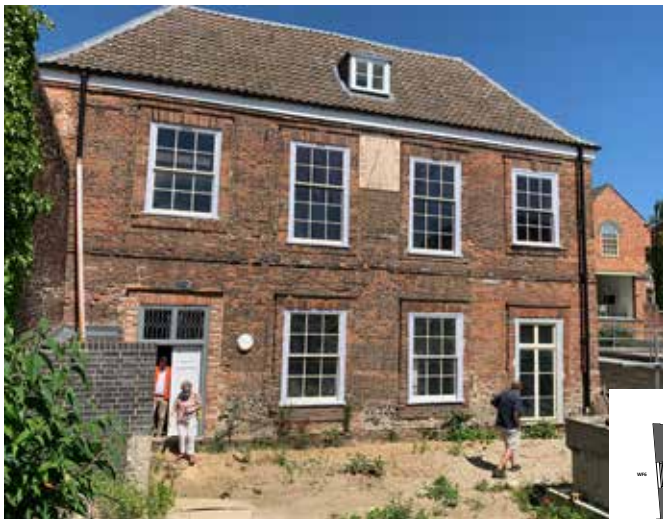
Henry Howard, the sixth duke, had bought the Friary site and developed it as pleasure gardens to serve the palace further up-river. It is now thought that the rubble-built section of Howard House on King Street is part of the old precinct. The south wing, built at right angles and at a much lower level, is probably later, with Pevsner dating its brick façade to about 1690. This four-bay elevation has large sash windows to ground and first floors; earliest surviving sash windows in England date to the 1670s, so these were very fashionable.

above: the south range of about 1690

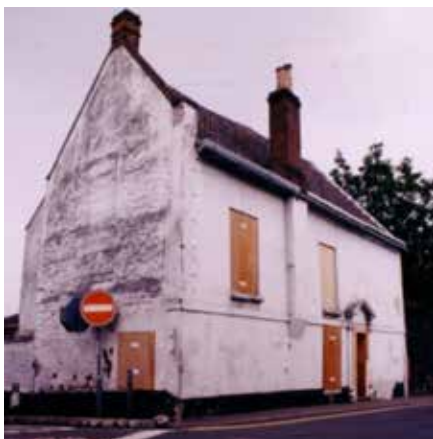
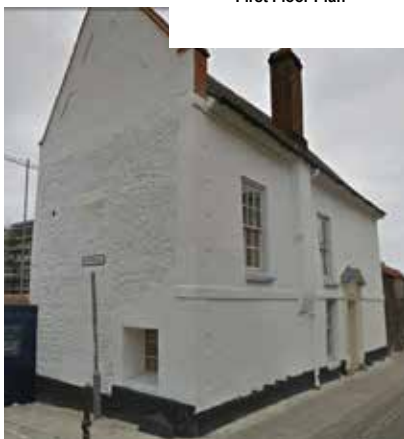
The two wings are knitted together by the insertion of a spectacular Jacobean staircase, built in the south-west corner of the two ranges shown on the floorplan below. The stair dates to 1630 and was imported from a larger building, possibly from the Duke's Palace which was updated by Sir Henry at about this time. This staircase, with its multiple half-landings, brings together the different levels of the two wings very cleverly, but there is no doubt that its original insertion was a rather botched job, pushing the supporting walls of the tower out of position in places and needing propping up with a variety of "table-legs" and odd pillars.

right: first floor plan showing the stair tower between the south and west ranges

below: the King Street (west) frontage in 1996 and 2019 (1996 image from <https://www.edp24.co.uk/features/norwich-s-great-survivor-building-still-stands-proud-1-5859262>)

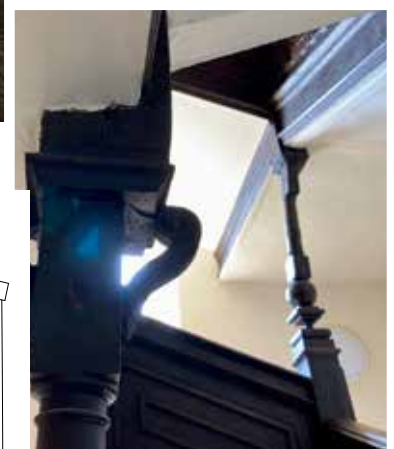
The magnificent staircase showing some of the "pillars" needed to reinforce the structure

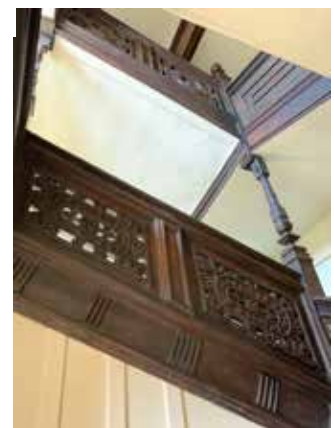
The most notable feature of the staircase, however, is the openwork panels instead of balusters, with strap and leaf motifs.

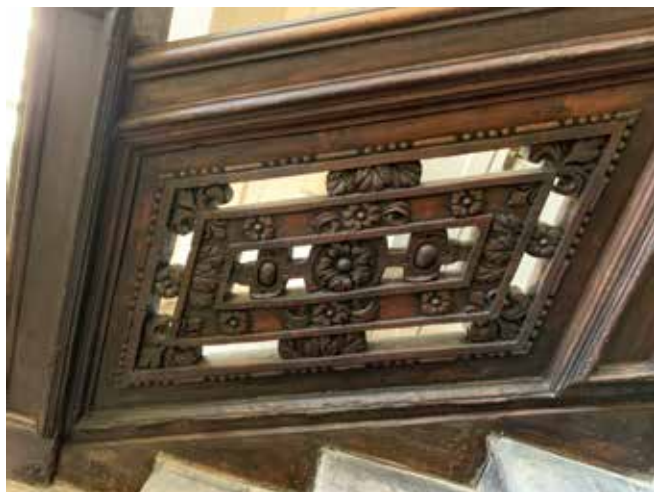
One of the fine remaining openwork panels

By the time Norwich City Council boarded up the empty building in 1999, several of these panels had been stolen, so the restoration included plain new panels in keeping with the originals.

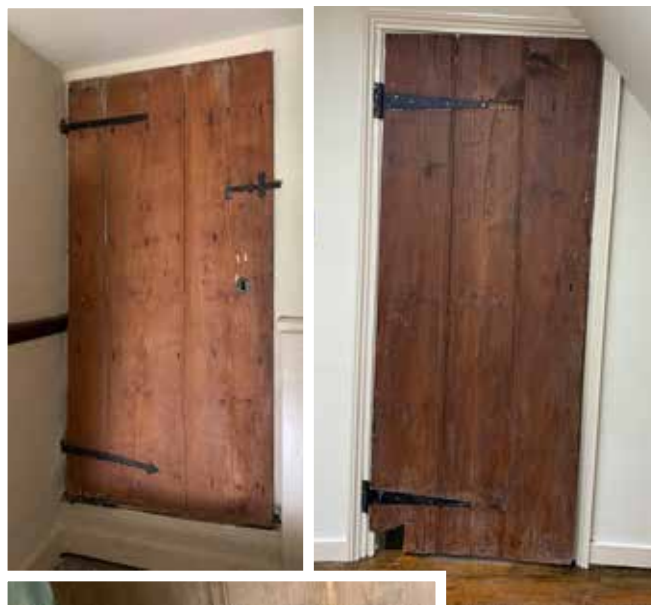
Two of the retained plank doors and one of the hand-made strap hinges

The restoration architect, Ruth Brennan, has carried out an extremely thorough repair and renovation job, with all historic features carefully recorded, repaired or replaced. The gable wall onto Mountergate has been rebuilt with new hand-made bricks, a clumsy twentieth-century first-floor extension has been removed, the roof is watertight and the flat dormers have been repaired with extra-thick lead casing. The cellar/undercroft has been cleaned up, although it is naturally quite damp still, and the barrel-ramp leading down the stairs has been retained. Old floorboards have been saved where possible, moved to create new floors, and some very old plank doors retained for the second-floor attic rooms, along with their original strap hinges.

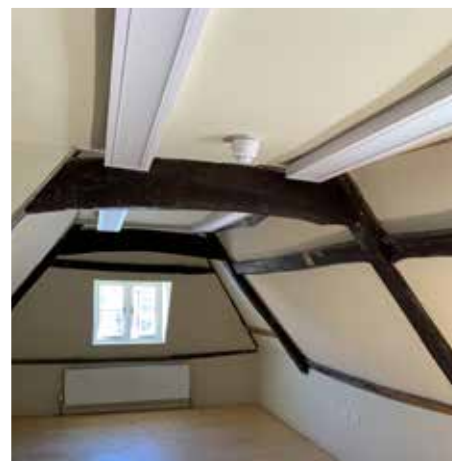
*above:
the typically
seventeenth-century
roof construction*

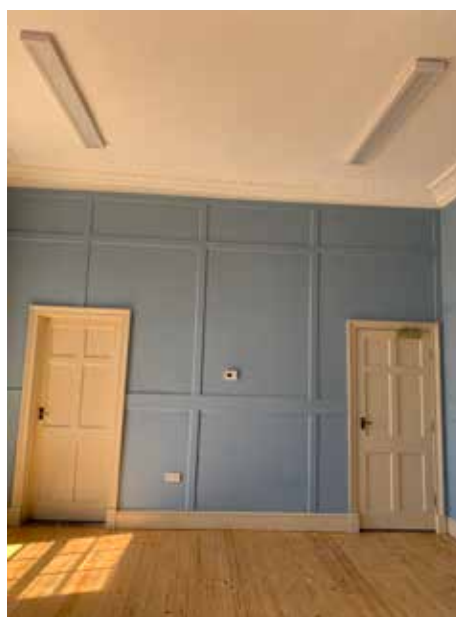
*left:
the modern treatment
of the inside of the
building for office use*

Minimal modern services have been introduced with the aim of using the building as offices. For this reason some rather unsightly strip lights have been installed, but they are apparently easily removeable. Speaking personally, my biggest disappointment is with the wonderfully-proportioned *piano nobile*, now called the Board Room, which has had its panelling carefully repaired, but is painted an unsympathetic blue, with glaringly new light floorboards and the afore-mentioned strip lighting. Somehow it has lost some of its magic.

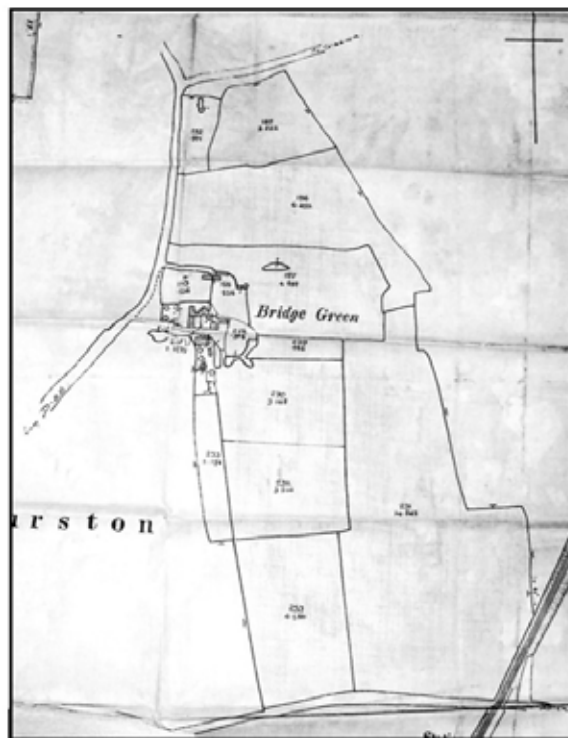
Fig.1 Map from 1921 Sales Catalogue

The best place to start looking for documentary evidence is the catalogue of the local record office; in this case the Norfolk Archive Centre at County Hall. Searching through the catalogue for Thelveton estate items uncovered the title deeds of the Mann family of Thelveton Hall. Among these deeds are the Sale Particulars and Agreement of the conveyance of Bridge Green Farm (fig.1). The farm premises and land were sold to Sir Edward John Mann (of Thelveton Hall) in 1921 by Sir Kenneth Hagar Kemp (of Pentlow, Sheringham), whilst in the occupation of Arthur Valentine Boulton. It also mentions title to the property commenced with the will of Sir William Robert Kemp in 1861.
