# Norfolk Historic Buildings Group

# Newsletter

Number forty-six  
Autumn 2022

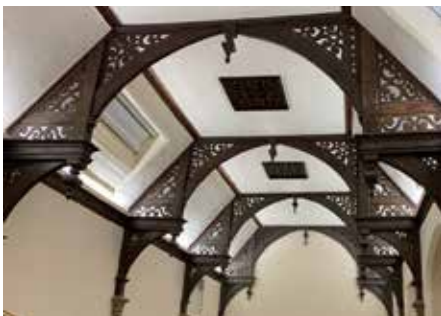
We found this tucked away in The Whipple Science Museum in Cambridge whilst hunting for a shoe last. - a wonderful hall containing a pendanted, hammer beam roof with spandrels of flat scrolling timber.

The building is to be found on Free School Lane. It was built in 1618, completed in 1628, as the first Cambridge Free School and this room is the original hall of what became the Perse School. Originally it had two wings and a small courtyard. Falling into disrepair in the early nineteenth century, it then housed the Fitzwilliam Collection until the new museum was completed and subsequently reverted to a school with an added wing in the same style. In 1890 it was bought by the University as part of the New Museums site. The building became an Electrical Laboratory, then part of the Department of Physical Chemistry before the Department of History of Science converted it in 1975 into an intriguing museum housing the Whipple Collection.

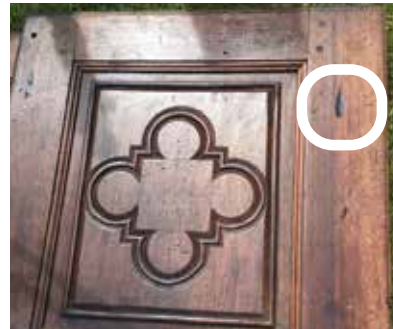
A deep taper-burn on a French cupboard door was discovered in an antiques market by Les and Vanessa Scott.

These marks appear just about everywhere. There are obviously early ones around windows, doors and fireplaces thought to protect against the entry of unwanted spirits. They have been found in roofs, placed there before the covering was installed – thought to be protection against fire. They also appear in places close to where the marital bed may have been (Home Farm, Hempnall), - for fertility? They are also seen on equipment such as wine presses – possibly for a blessing on the product. Not many are found on cupboard doors and it would be useful to know the date of these doors. They are obviously older as the joints are pegged – in this country eighteenth and early nineteenth-century doors were made this way - a little late for protection marks perhaps? Was the timing different in France? Has anyone else seen one on a cupboard door?

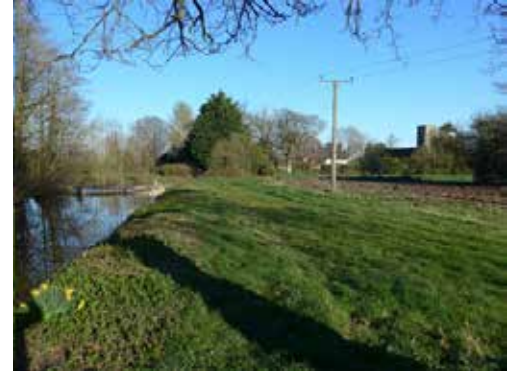
This was illustrated with three examples in the parish of Tacolnестon, all of which are discussed in the NHBG Journal no 4 on that parish. The first case is 275m from the church is still complete and water-filled; medieval and post-medieval pottery was found when the ditches were dredged. Field names support the suggestion that this was a manor house site, in the typical Hall-Church complex of later Saxon times.

*Manor-house moat site in Tacolnестon close to the church?*

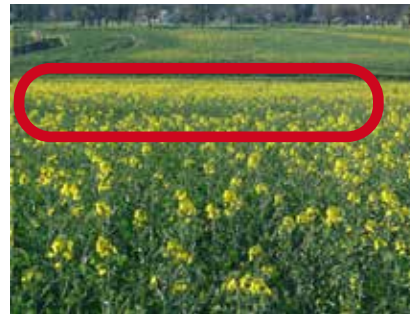
*William's Manor moat - visible as a crop mark? later flowering showing deeper soil*

In contrast, the second moat is what may have been the site of the second manor within Tacolnестon, Williams Manor, is now all but invisible on the ground. However there is an aerial photograph showing crop marks of at least one moated enclosure and the 1845 tithe map and early OS maps shows a single ditch of what may have been a second moat. A sketch map from the 1650s and a “Dove Hose (sic) Field” name for an adjacent enclosure support the inference that this was a manor house site.

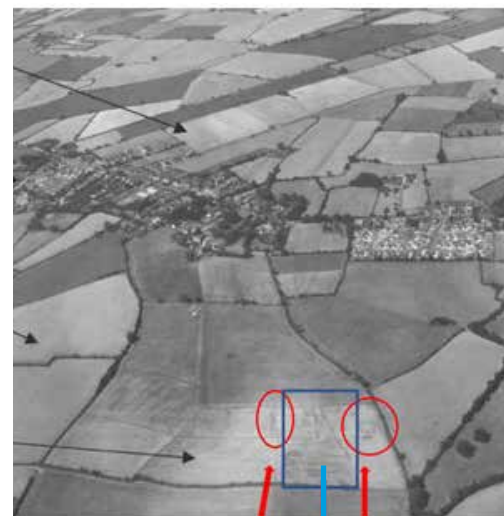
*southern arm of second moat? (Present on early maps) Jack's Wood moated enclosure?*

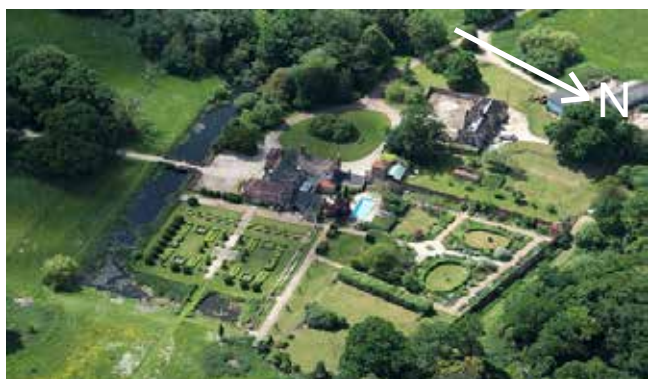
Tacolneston Hall  
/?Sparkes

The third case is what is now known as Tacolnестon Hall, and may have been the farmstead of Sparkes in late medieval times. This is surrounded by a moat consisting of one full arm and two

halves, but this may be a modern-era garden feature, since part of the moat lies where the tithe map shows buildings. One well-known complication is that what appear to be later garden features may have been created from medieval homestead moats.

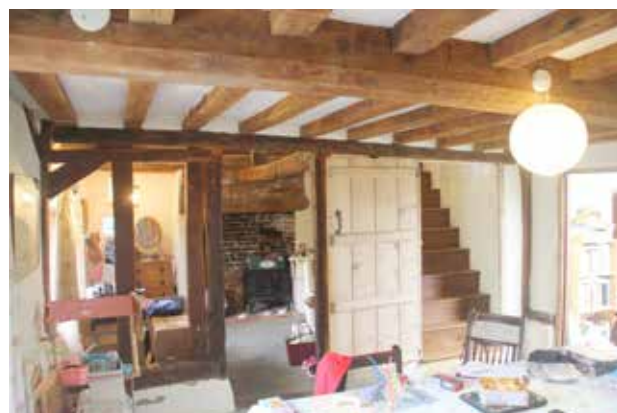
*Looking west in the hall at the steep stairs and into the service-room extension*

that the timber framing between the hall and the service cell was originally the external wall with multiple braces and an upstairs window. Also on the gable end in the service room was another brick stack which had been capped off. The stairs are steep, starting from the hall and located in the service room. Care had to be taken not to hit one's head on the descent!

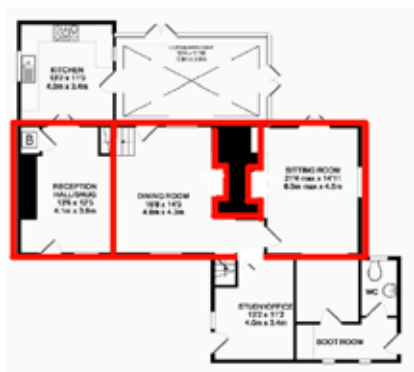
*Current floorplan - the original house in red*

On completion of the outside tour of the house, we split into two groups and explored the interior. The central chimney stack has two hearths between the hall and the parlour, with the hall hearth having holes for mounting the chimney crane to enable the cooking pots to be swung on and off the fire. We saw evidence

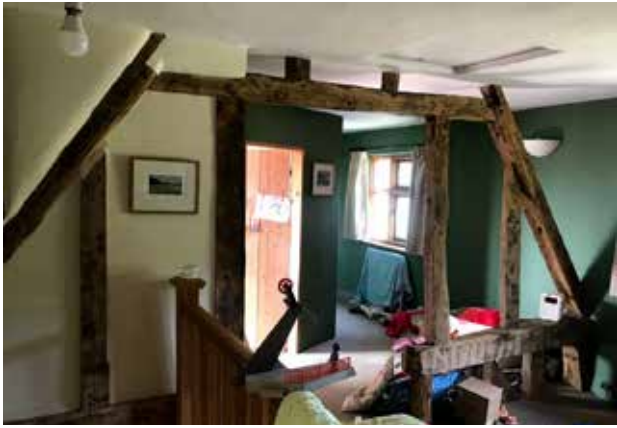
*The original end wall of the house, showing the steep roof and position of the gable end window*

Upstairs, having negotiated the steep stairs, we could see the original rafters, which Ian noted were set at 55 degrees, so was probably thatched originally. In this frame was evidence of an unglazed window, with an empty diamond shaped mortice for a mullion in the cut-through tie beam, confirming that it was once an outside wall.

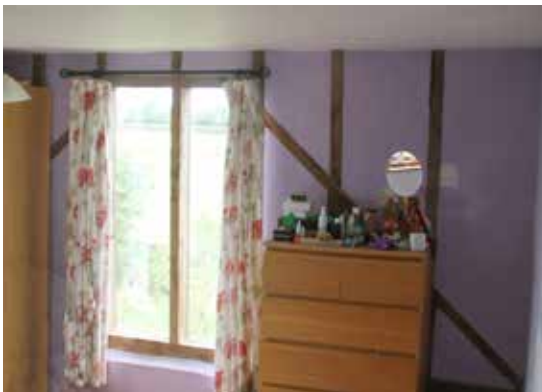
*The thin, nineteenth-century, primary bracing*

In the room above the clay-lump parlour, the wall was considerably thinner with slight timber framing from the nineteenth century which Ian described as “primary bracing”.

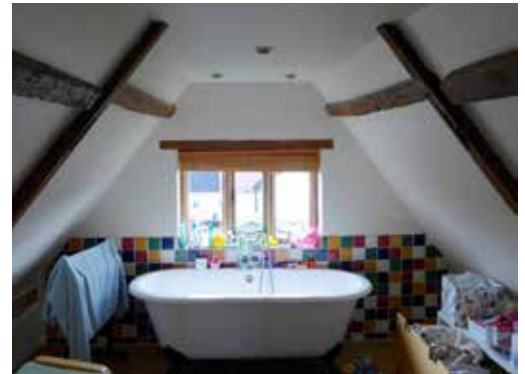
*The shaved purlins in the roof of the pantiled extension*

Ian thought that the extension with the pantiled roof had been added in the eighteenth century as the purlins in the roof had the typical shaved ends to fit into the mortices in the principal rafters. The remainder of the roof is slated.

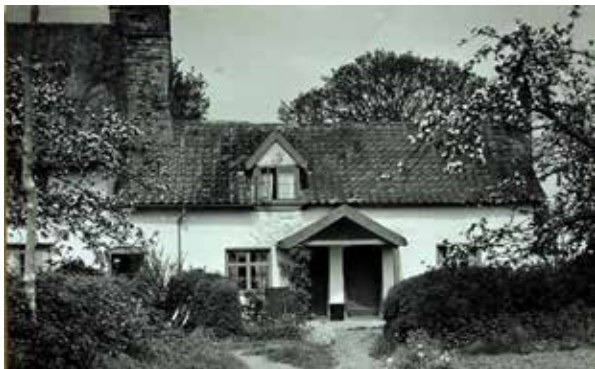
English Heritage photo of 1947 <sup>2</sup>

Old photos show that the house had been divided into three cottages but sale particulars of 1952 show that it had been returned to a single dwelling when the dormer windows were extended and added. The official listing text suggests that the rendered part is 17<sup>th</sup> C and the rest later <sup>1</sup>.

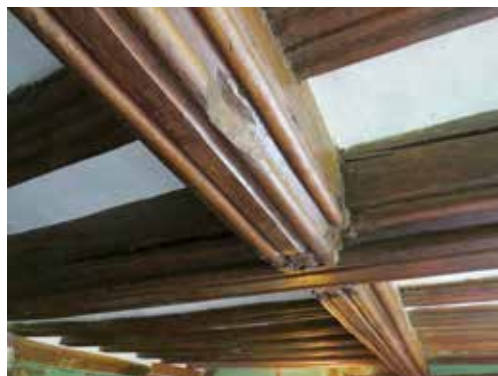
The mortices for the partition are visible in the rough principal joist (which turned out to be elm (*ed*)). The stairs now lead from this room. In the stair well is an anomalous timber post with a tenon and wall plate, below the level of the current wall plate. The roof structure at this end of the house appears to be 18<sup>th</sup> C with shaved purlins.

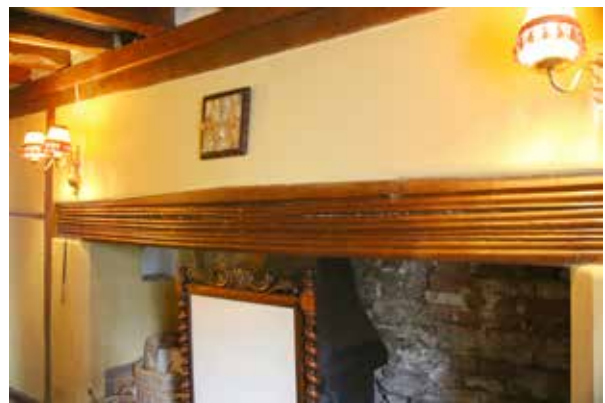
*the moulded bressumer or mantle beam of the parlour fireplace*

*part of the decorative paint scheme on the parlour principal joist that must have been above the later ceiling (since removed) and therefore escaped being varnished over*

At the other end of the house, the parlour is fully timber framed with large studs, arched braces and plain flat-laid common joists all suggesting a date of c1600, although the mantle beam has roll mouldings which may date to c1550. There is some paint on the plain, chamfered, principal joist being the remains of an early decorative scheme.

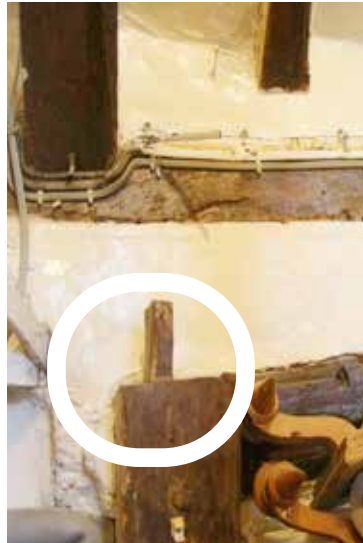
- What is that anomalous jowled timber post in the stairwell with its upright tenon (apparently for a tiebeam) just below the current wallplate?

left  
the anomalous  
jowled post  
with tenon

Subsequent to the visit, Les Scott raised the possibility that that the remnant jowled post and tenon (pictured above) were part of a jetty structure, since removed.

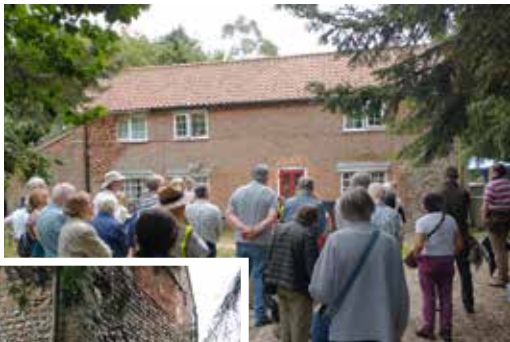
*The western wrap-round gable with the reused stone from the Castle below: the truncated principal-rafter roof (photos: Michael Brown)*

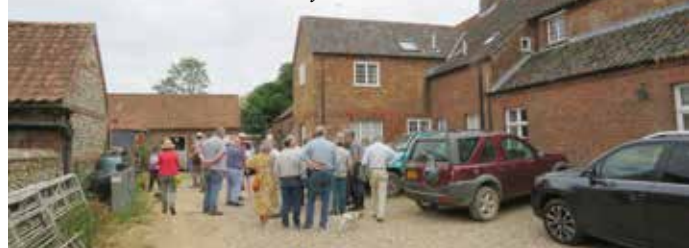
*The rear of Burwood Hall Farm - a model farm of 1793 replacing the medieval Burghwood Manor; built inside the castle bailey.*

Burwood Hall replaced the medieval Burghwood Manor. The hall and farm were built within the Norman enclosure. The farmhouse dates from 1793 and was where Edward Coke (of Holkham) was born and started farming. Here with the guidance of Mark and Tom Butler-Stoney and Susanna Wade-Martins we saw a variety of farm buildings and began to recognise the differences between stables (high doors with better and more spacious accommodation than many of the farm workers), cow sheds and dairies (with cows and modern robot milking machine) and threshing barns. The barns had brick threshing floors and were built of brick which absorbed moisture from the crops. In contrast with some

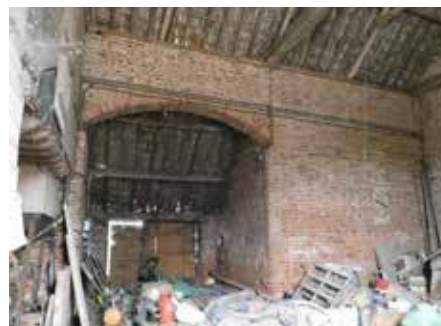
*left: The threshing barn, with a reduced-size south door opposite the full-height door behind the photographer below: Animal buildings in the foreground with the taller barn behind*

threshing barns, Burwood Hall's barn had smaller doors on south side, reduced in size when winnowing machines came into use and it was less essential to have a good flow of air moving through the barn. Such changes reflected changes in technology and in the balance between the production of wheat and meat. Cattle had been kept primarily to provide manure but as markets changed in the 1870 and 80s, when wheat began to be imported from US and the development of the railways, cattle became more important and farm buildings reflected these changes.

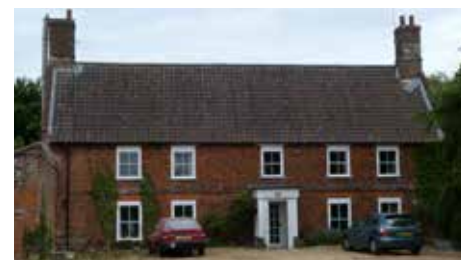
stables built of red brick were meant to be seen - they face the road - and the gable end is of fine quality flintwork which is even galleted. The farmhouse has wrap-round C16 gable ends in brick and is two storeys high. The bricking-up of the central section is dated to c1700-1720, with brick probably replacing a timber framed structure (and behind is a later extension).

*the join between the gable and the later bricking-up (photo Les Scott)*

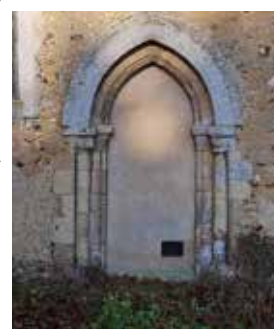
*Priest's door in the south chancel wall*

There is part of a preaching cross placed on a C15 table tomb. As Ian Hinton (our guide for this part of the tour) indicated, the core of the church was Norman, as shown by the priest's door in the south chancel wall which has Norman shafts but a later Early-English pointed arch, did the style change during the building process or was the later pointed arch a replacement?

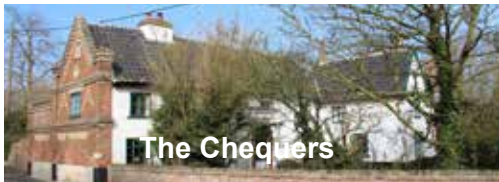
The Chequers

5 from the rear range inserted floor, dated -1553

1 sample from the frame of the rear range - **did not date exactly - no sapwood, but matches the ceiling samples - so is almost certainly 1553 too.**

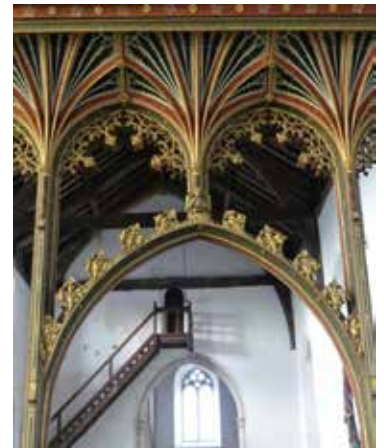
Bodley's reworked screen from the chancel side. Also showing the off-centre tower arch

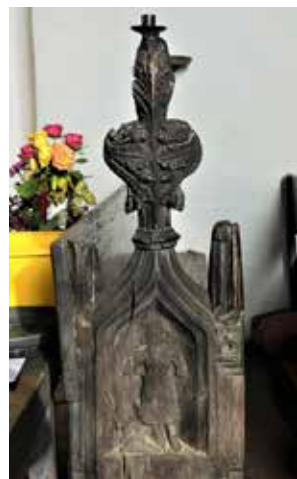
*One of the damaged bench ends with a de-faced, planed-back figure and nailed-on back*

There are some fine bench ends, probably made just before the Reformation to judge from the decorative details below the carved figures. They have all been defaced, yet enough detail survives to appreciate that they were finely made. It can be seen that they were originally just benches as the backs are nailed on, requiring some of the figures to be cut back.

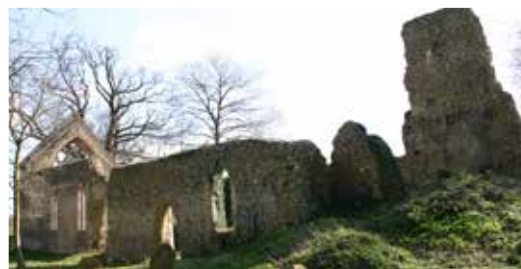
*Nave and tower remains from the north-west*

The feeling amongst the ex-military in the group was that the collapse was more likely to be caused by the effect of two years of heavily-laden USAF bombers from RAF Tibenham flying low over it during the war.

Remedial work of the 20C included a concrete ring beam at the top of the east wall, brick buttresses and a renewed porch doorway. The poor bonding provided by flint construction shows up as large cracks right through the walls.

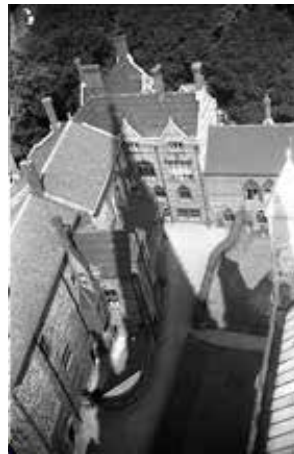
Adrian Marsham's photo (left) of the eastern façade shows the tower, built with flint with stone quoins. The Norman flint rubble walls can be seen at the top but are obscured at lower level by the C19 restoration.

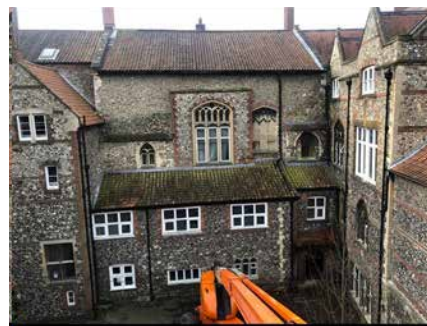
George Plunket's views of the tower and palace complex (right) were taken in 1937<sup>3</sup>.

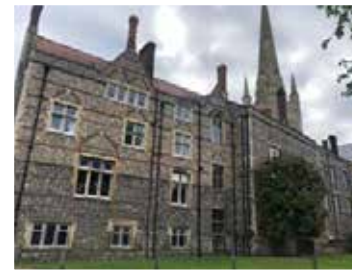
The photo of the western façade of Losinga's Palace (below left) shows the tower standing out in the centre of the current western façade behind the tree, with Losinga's Palace on right. The additions on left are more recent. The watercolour by Mrs Stanley (on the right), now in Norwich Museum & Art Gallery collection, was made before the C19 additions and shows the tower in the centre with Losinga's Palace on the right, still attached to the Cathedral.

Plunket's photo (earlier) shows part of this hall on the right hand side. The lower part of the façade is of flint rubble, with tracery windows and arch of a door which gave access to the undercroft. The first floor has a covering of brick, flint and chert, part of C19 renovations. The blocked door, partially below ground now, can be seen on the right.

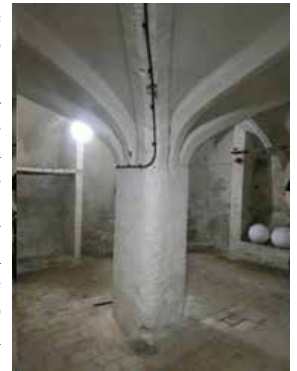
had undercrofts, as shown in the sketch below by John Walker who was archivist at Norwich School. That under De Losinga's Palace is a barrel vaulted undercroft of 5 bays with transverse ribs and dates from the early C12. It extended as far as the Cathedral.

As John Walker's sketch below shows, there is a small, vaulted chamber beneath Losinga's Palace undercroft, is shown in the photo right. This is the space which Whittingham calls the crypt and John Walker labels as 'the dungeon'.

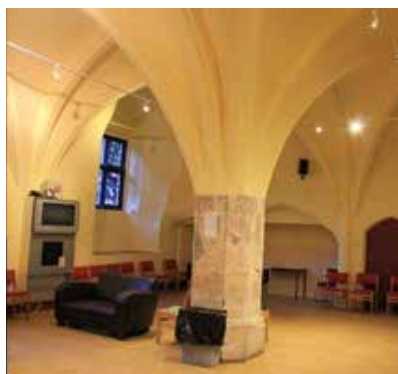
photo (above) shows it in use as a recreational room for Norwich School.

In the early C14 one of Bishop Salmon's many changes to the Priory was the insertion of stone vaults into the Tower - a rib-vaulted undercroft of four bays with a central octagonal pier and hollow chamfered arches. Whittingham suggests this was used as a kitchen and Norwich Museum has several C19 pictures of it in use as a kitchen. Terry George's

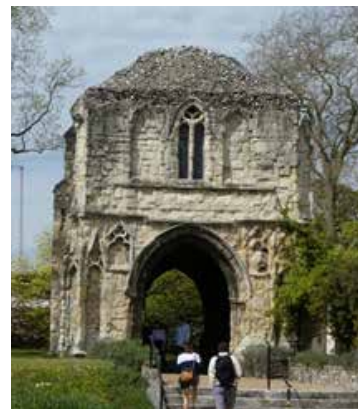
magnificent aisled hall (36.6m x 18.3m) to the north, as shown on Whittingham's plan. This was aligned N-S with kitchen, buttery and pantry at the north. This was an impressive hall: its scale was exceeded only by C13 Archbishop's Hall at Canterbury, and was comparable with later royal C14 halls at Westminster. Only the two bay porch remains with shafts with lively foliage capitals supporting tierceron vaults with carved bosses. This was drawn/recorded by J A Repton in 1798 (below left).

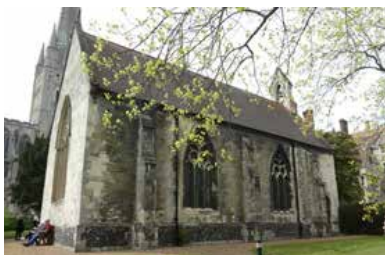
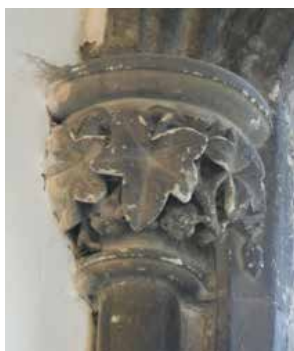
In the C12 a chapel (St Mary's) was built to the east of Losinga's Tower & Palace. Bishop Salmon replaced its apse with rectangular east end. It was destroyed in 1540-50s but Bishop Reynolds (1660-1676) had a new chapel built using masonry and tracery from Salmon's chapel (below) including the stiff leaf capital (below). It was built on the medieval foundations and lower courses of southern bay of Salmon's great hall. The altar of this chapel was aligned with Cathedral's high altar.

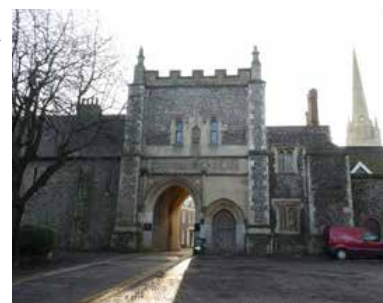
In 1435 the gatehouse of the Bishop's Palace (with brewery and granary) was constructed with two entrances - one for people and one for carts - two turrets, battlements with tracery and shields, and with a barrel-vaulted undercroft.

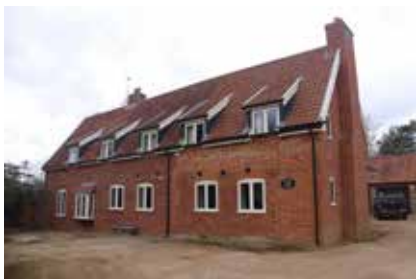
The house is of 1½ storeys, built of brick in English bond with an off-centre stack and a pantile roof, although it was previously thatched. There is a modern bay window to the second bay where formerly there was a door in the lobby entrance position. There are 5 modern dormer windows. The rear of this range is built of flint rubble with a roof raise in brick making it two full storeys. There is another range built at right angles to the rear.

The central ground-floor room has a fine ceiling with crossing axial and transverse principal joists with deep chamfers buried in the walls with chamfered common joists laid in a chequerboard or counterchange pattern. Unusual for Norfolk, but many examples

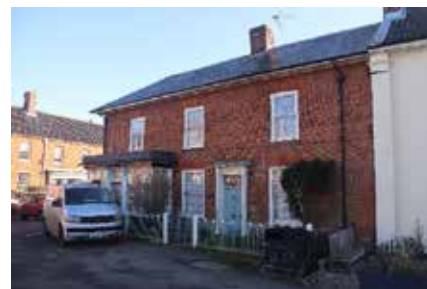
Hewkes House is located on the east side of the Marketplace in Reepham. It is of two storeys plus part attic with a red-brick façade in Flemish bond and a shallow slated roof with a deep overhang with a hipped northern end. The sash windows are set flush with the wall surface. The attics sit above most of the front range with a cat-slide roof at the rear. The roof structure is fully visible, mostly of sawn-square pine but with some of the larger timbers in oak. It has a single set of in-line butt purlins, many of them are shaved to tenon into the principal rafters – generally an eighteenth-century feature. There are several reinforcing inverted "knees" in the attic rooms which are bolted to the floor, each of which sits adjacent to one of the principal rafters.

This house is a re-fronted older house. The setting of the sash windows could indicate an earlier date for the front wall than the listing suggests. Much of the narrow hall behind the front door is cut through an earlier sizeable chimney stack as an arched passage. The positioning of this stack would suggest a seventeenth-century layout of a three-celled house, possibly timber-framed with a lobby entry, later refaced with brick.

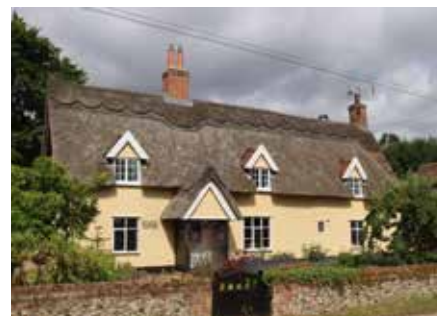
Mulberry Cottage is listed as an 18C timber framed house. It consists of three cells with an off-centre chimney stack and an additional stack on the north gable. The gable walls are of brick and the front and rear walls are still timber-framed with no mid-rail, all on a low brick plinth and all rendered. The roof has single side purlins with clasping collars and ridge piece.

There is a two-storey extension at the rear above a cellar. It is also thatched, next to a single-storey pantiled lean-to.

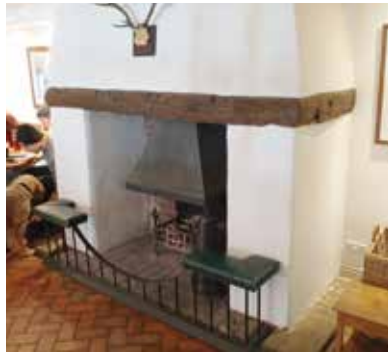
The chimney at the Rose & Crown

I noticed the chimney stack in the rear room at the Rose and Crown in Snettisham whilst eating lunch out recently. It appeared to have a wrap-round mantle beam, which reminded me of one I had worked on in the 1980s in France. In fact the Snettisham example was constructed as a decoration, with the return parts only mitred and nailed to the main beam.

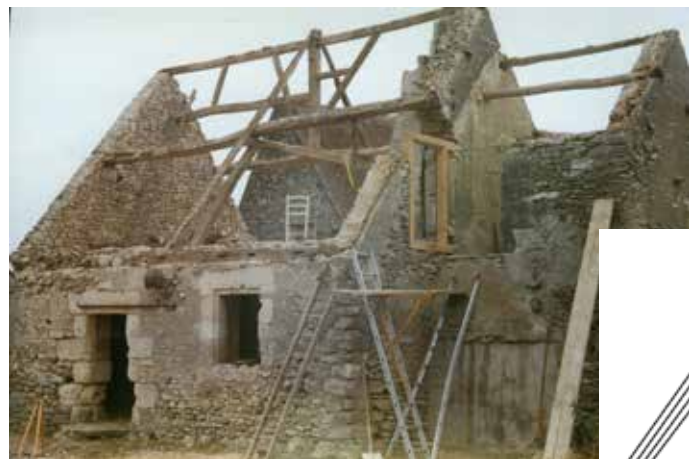
above: during the roof replacement the previous year - an interesting mix of truncated principal rafter and king-post construction

The chimney in France that I worked on was near Loche in central France, south of the Loire valley in the main limestone belt. I spent several long summers developing building skills in the late 1970s and early 1980s with a group of French and English friends. This house, thought to be seventeenth century, was part of a group of buildings in a small hamlet and it had been used to make the bread for the hamlet until the early twentieth century. It had lain empty for much of the time since and was in a sorry state. We had replaced the roof covering and most of its structure during the previous summer (which appears to have been a french version of a truncated principal rafter roof. Except that here, the purlins are continuous and rest on the collars which are then supported by the second, truncated, principals. The collar, in turn, supports the king post and braces.

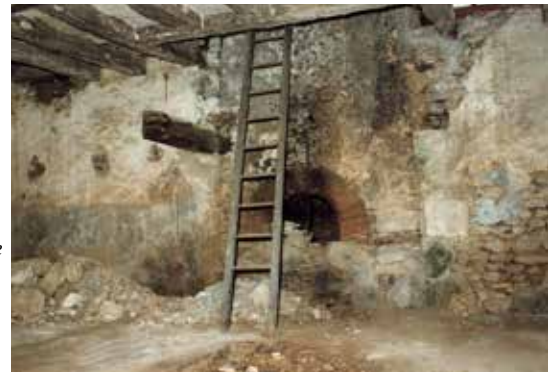
below right: the new frame with corbel, supported whilst setting

In 1986 one of the tasks was to replace the chimney which had collapsed some years before. It had been inserted into the building and not bonded to the flint gable wall (the centre one in the picture above) and at its base it was supported by timbers cantilevered from the wall - rather than by the typical brick or stone piers - and one of the side pieces had rotted off in the wall.

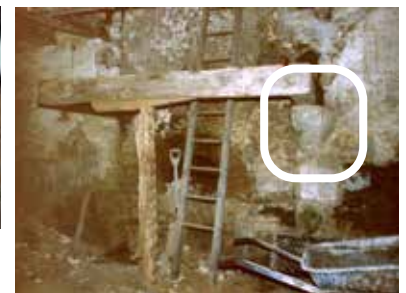
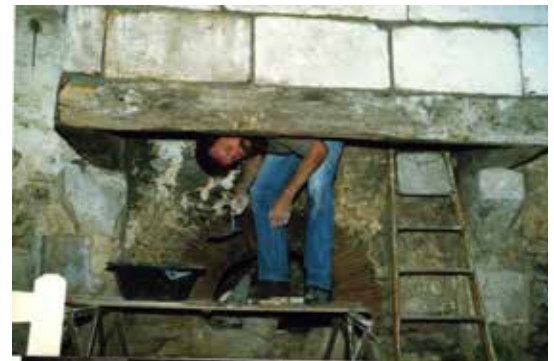
the new tenoned mitre

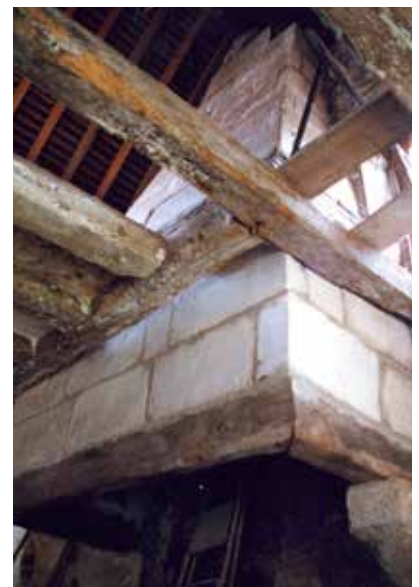
below: the completed chimney with the prominent new corbel

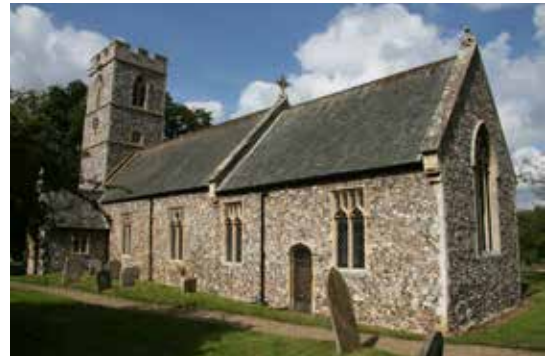
Above:  
St Andrew, Kirby  
Bedon

At Kirby Bedon St Andrew, some repair work was being undertaken on the porch, so the builder's detritus was evident during our visit. Scattered around the church, particularly on its north side were small pieces of broken slate from the roof. Tim picked up three pieces and commented on the differences in colour and appearance.

Putting this information together, we have evidence that two different UK slate types were used at Kirby Bedon and one imported Norwegian type. These must have been the result of separate re-roofing episodes. Slates were definitely part of a nineteenth-century North Sea trade, and it will be interesting to know how many other Norfolk churches have roofs dressed in this distinctive, sparkly slate.

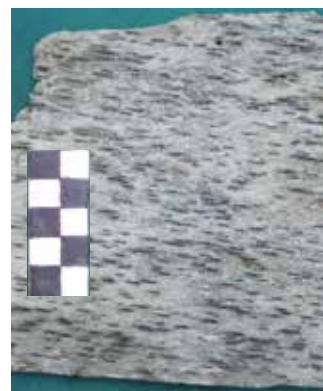
Close up of the  
decorative schistose  
slate from Norway  
on the chancel roof
