# Norfolk Historic Buildings Group - Building Notes

A photographic glossary of examples of features found in Norfolk Houses that have been surveyed by the NHBG

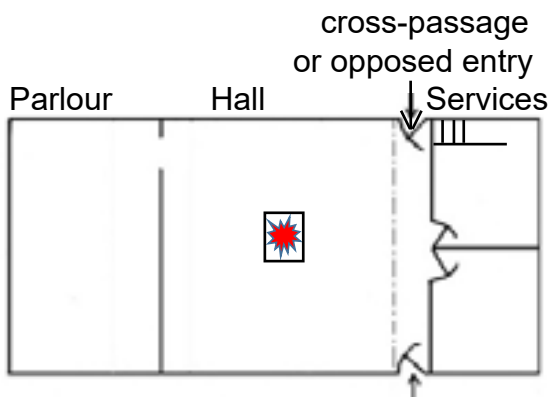
Open Hall - central hall open to the roof, two storeys at either end. Open fire in centre of hall - up to c1550

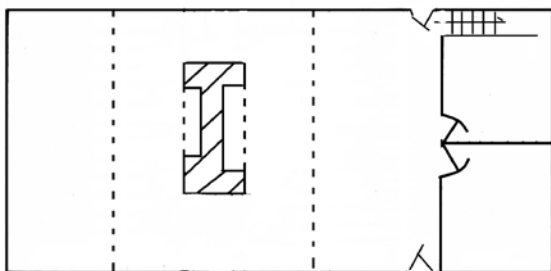
Adapted open hall with inserted chimney and floors.

Note - no principal joists flanking the chimney. A typical sign that the chimney has been inserted

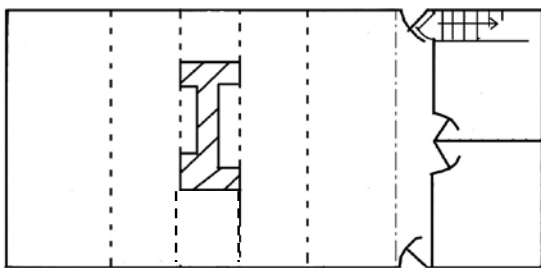
Opposed entry with two floors throughout and original chimney - c1500-1600, more commonly 1550-1600

Note - principal joists flanking the chimney

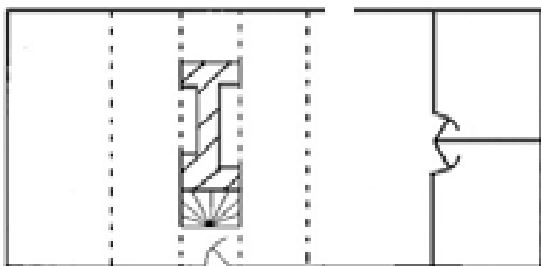
Lobby entry with two floors throughout and original chimney c1580-c1670, stairs adjacent to, or opposite, the stack

Frequently updated from previous example, leaving evidence of original opposed-entry doors

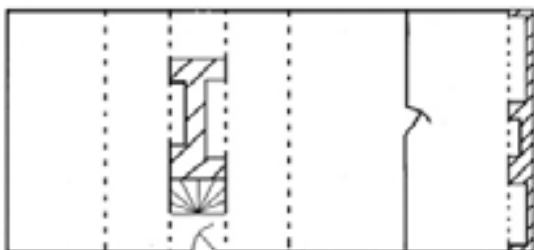
Lobby entry with added gable- end chimney - c1600 on, removing the service rooms - usually an adaptation of one of the previous two layouts

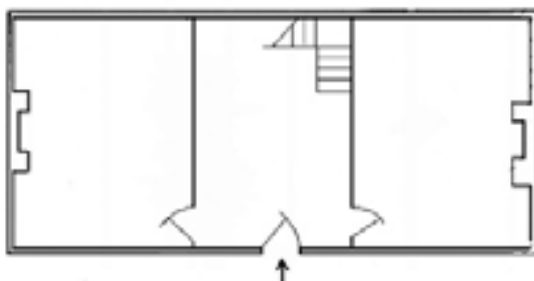
Symmetrical house - unheated central bay - c1650 on, later examples usually brick built. Some early examples with brick gables and timber frames

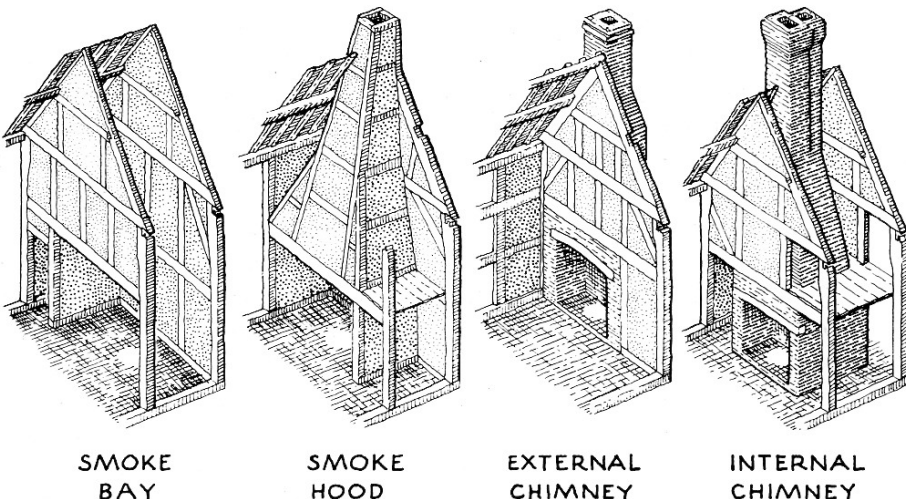
The textbooks tell us that there was a period between the open-hall house and the two-storey house with a brick chimney, where some houses had smoke bays or timber-framed chimneys, usually said to be between 1500 and 1550. Not quite that simple - the Hempnall survey showed that at least 2 open-hall houses were built with smoke bays, perhaps as early as 1450.

The Tacolnston study showed that two-storey houses were still being built in 1645 with timber-framed chimneys (dendro). Several were found, each of which had had a later brick chimney built inside the original timber framing. Whether this was a cost issue (expensive bricks at the time) or another reason is unknown.

External stacks are unusual in East Anglia.

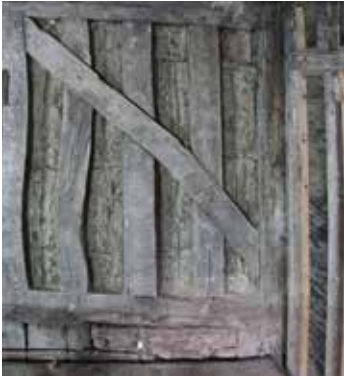
#### Close Studding (15-17C)

Closer = earlier or wealthier (or both)

The image above left is particularly close - could be pre 1500.

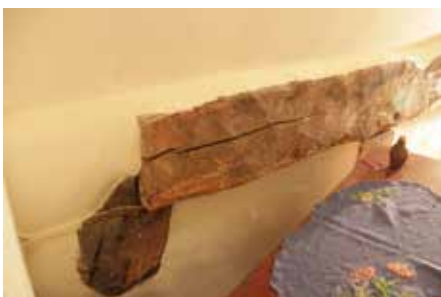
The scalloped effect of side-axe-prepared timber.

Timber can be cut with a side-axe, or sawn, either over a pit, or on trestles, The side-axe leaves shallow scallops. The pit-sawn timber has saw marks almost at rightangles to the timber (centre), whereas trestle saw cuts are at around 45°. Not strictly dateable as it depends on the carpenter, but axe-cut would normally be earlier, pit-sawn timber normally later and and trestle-sawn latest.

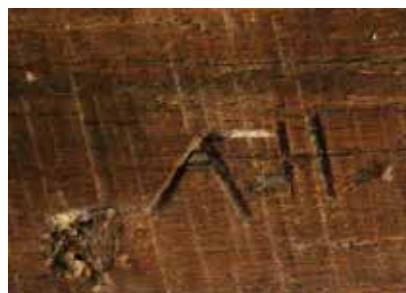
The almost vertical saw marks of pit sawing.

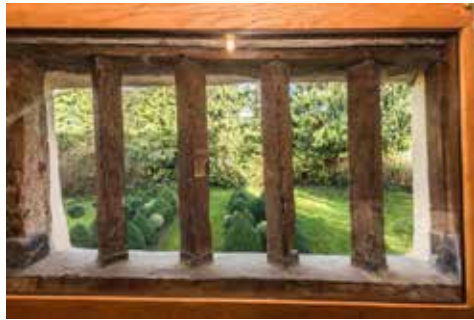
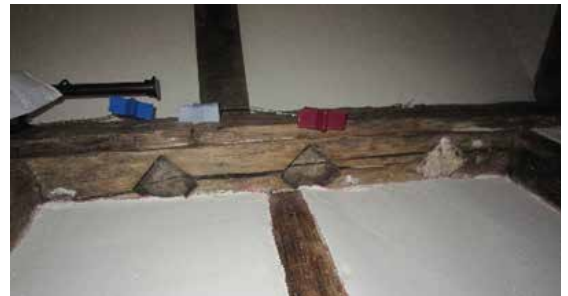
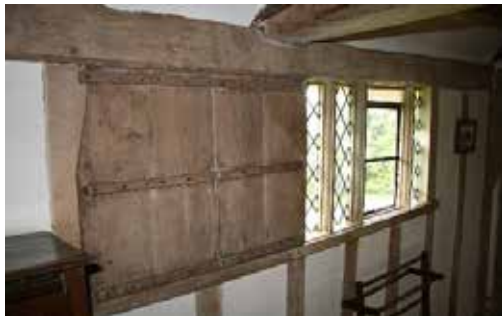
**Unglazed windows** had diamond-shaped mullions

A sliding shutter used to keep out the weather (this one dendro-dated to 1615). The grooves they slid in extend to one side of the window by the width of the window. The grooves were either made in the mid-rail or wall-plate (centre), or as a rebate (right) which was covered by another piece of wood to form the groove.

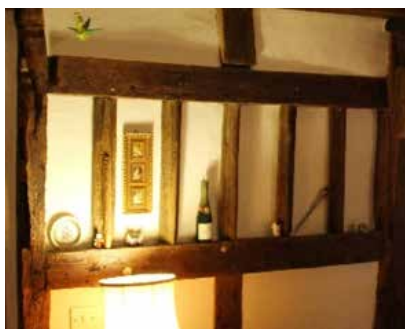
The empty mortices (right) are shaped for glass but the shutter rebate can be seen next to the curtain rail. Shutters continued to be used even after glass became common, perhaps just as curtains, so the presence of a shutter does not mean unglazed necessarily.

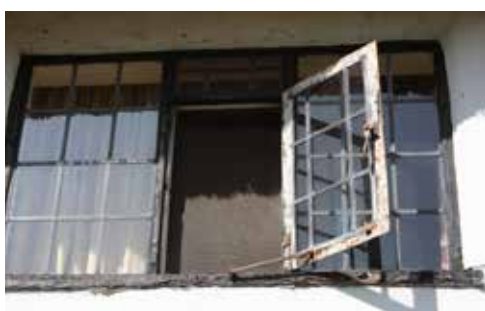
started in the late 17/early 18C, often with an iron opening light in the centre.

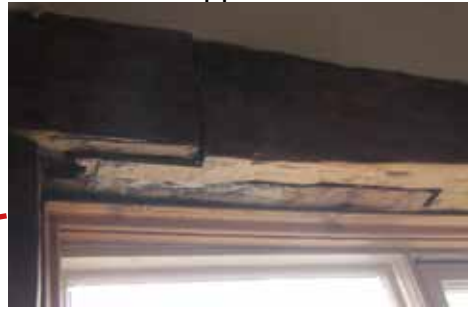
Face-halved scarf  
1550 on

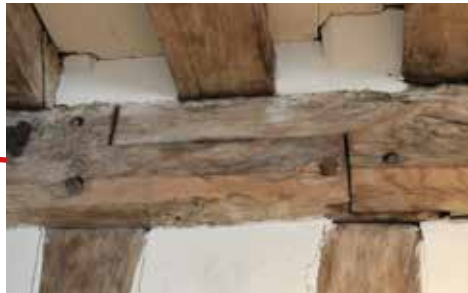
Edge-halved and bridled scarf.  
Long halving, short bridle and single peg (left)  
1400-1600

Short halving, longer bridle and 2 pegs (right)  
1500-1600

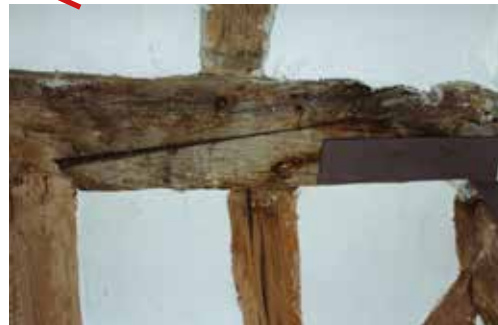
Splayed and under-squinted scarf .  
Up to 1600, little used after 1500

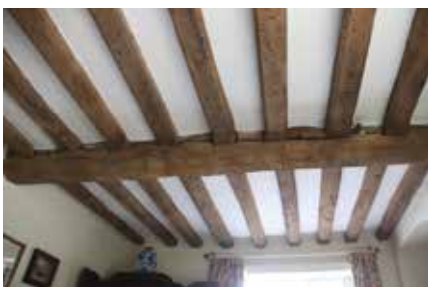
Laid flat, closely, C1500,  
-Litcham

Joists were laid flat up to around 1600, earlier ones were often installed very close together. After c1600, joists were mostly laid on edge (like modern joists) as smaller-section timbers can provide the same strength.

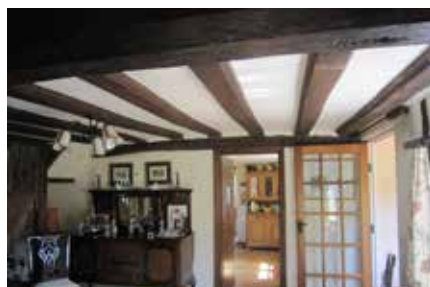
Laid flat, wider apart c1580,  
Hempnall

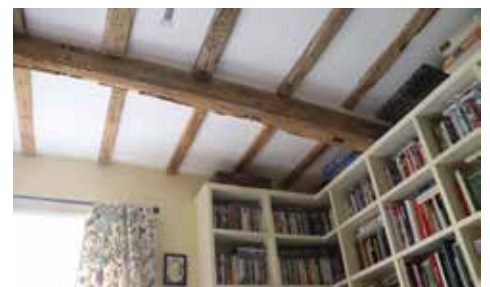
Laid on edge c1700  
Kenninghall

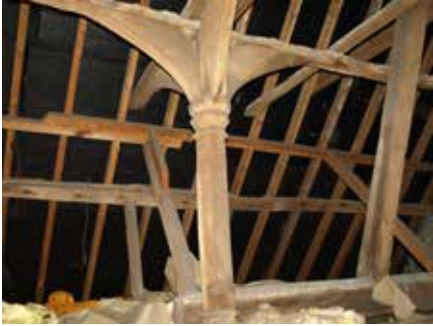
(left) Crown Post roof - before c1500. Higher status - meant for display in the roof of an open hall (the side purlins here are later insertions), or in upper chambers. If smoke blackened - open hall, if clean (as left) open from a first-floor chamber.

Both of these roofs are “common rafter” types, where all the rafters are the same size, and the purlins support each one.

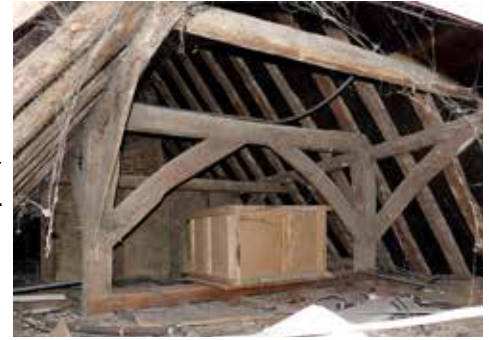
above) Queen Post roof - before c1550, a few until 1650. Used above open halls, but also in roofs above ceilings

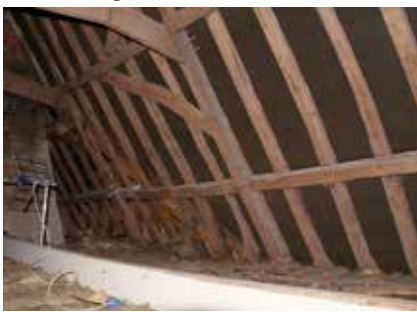
A development was the use of principal rafters. Every 5th or 6th rafter was larger than the common rafters and had purlins morticed into them to support the smaller common rafters in between - saving timber.

The purlins can be set end to end (as the image left) known as in-line butt purlins, or they can be offset, known as staggered purlins (right). This makes a stronger joint as the tenons can be the full width of the principal

rafter rather than having to meet in the middle.

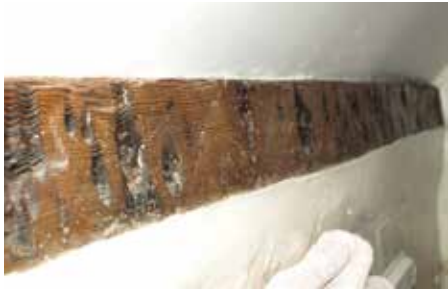
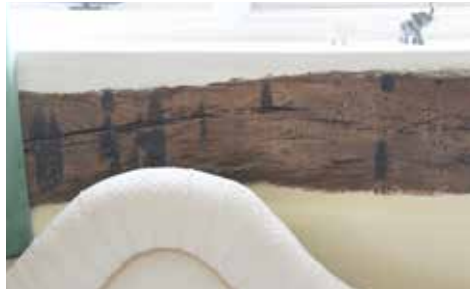
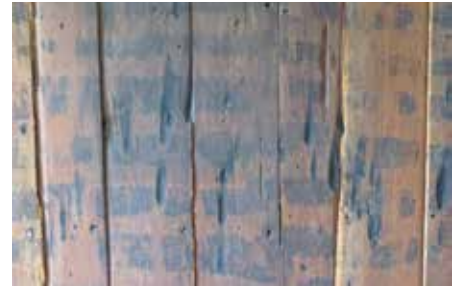
Multiple marks in bedroom situations -

Purlin in Rowan Cottage, Langham,  
(beneath the sloping ceiling)

Tie beam in Home Farm Hempnall

Bedroom wall in College Farm,  
Thompson

Other groups of burns are found in bedchambers, such as the three below, suggesting perhaps some form of fertility aid. Examples have also been found in other situations, such as on wine presses - perhaps blessing the product - and on a roof timber after assembly - possible fire protection?

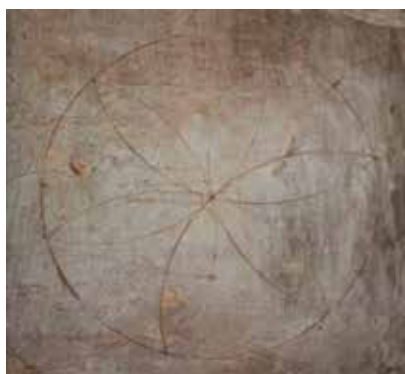
(left & below)

Two roses at the same scale: the  
plaster one is 25cm across in the Old  
Vicarage, Hempnall; the one below is  
5cm across in Kettleton, Fornsett End

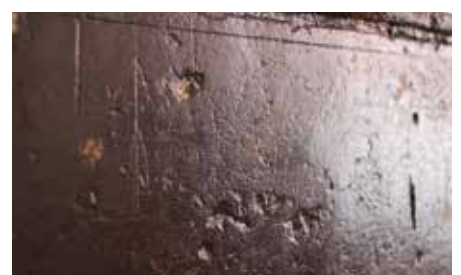
A series of faint daisies on a  
mantle in Coggeshall, Essex

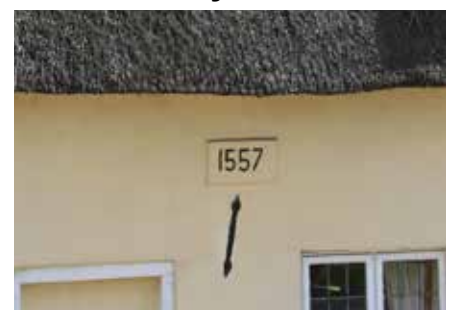
Catfield - 1557 - fits with likely construction date based on layout and other details

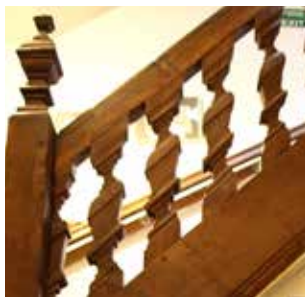
17C sculpted and turned ballusters  
from Walsingham

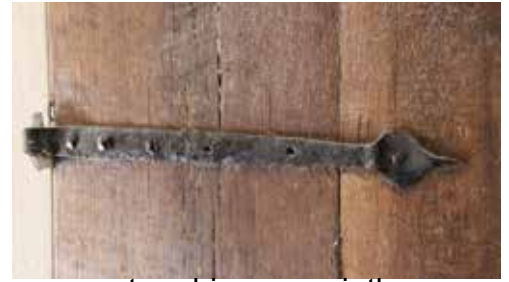
strap hinge on pintle

The earliest hinges appear to be of the pintle type, where the strap hinge sits on a pin attached to the doorframe. Made locally by smiths, some are still found.

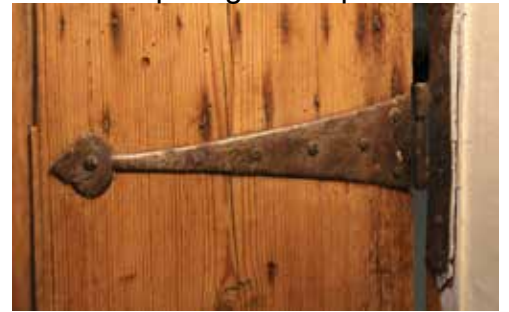
strap hinge on a plate

The strap hinge developed to have a plate fixed to the frame. Although the screw was used in houses in the 16C, most fittings were hand-made nails, probably until the end of the 18C

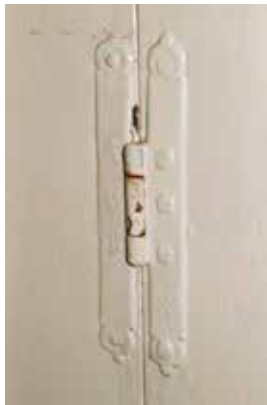
H shape

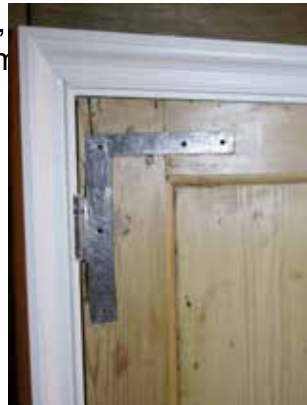
L shape

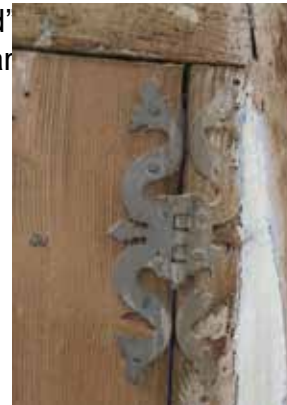
Cockshead

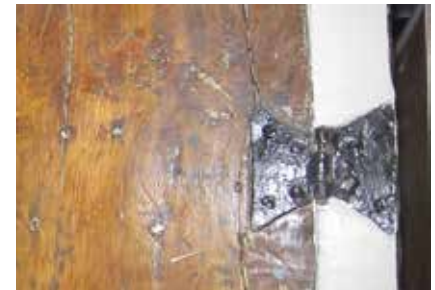
Butterfly

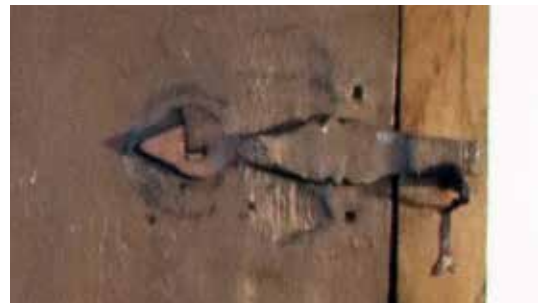
The majority of the locally-made simple latches have been replaced by the ubiquitous Suffolk latch, or by modern door handles and locks. A few still exist in their simplest form of a flat plate using a staple as the pivot (right - Old Vicarage, Hempnall).

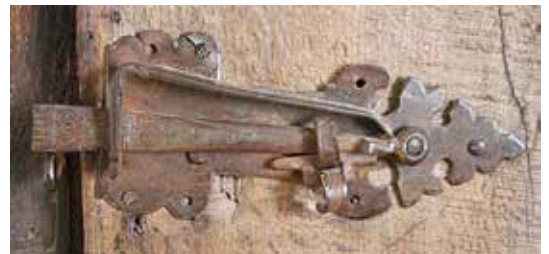
Fancy types of latch are noted in Linda Hall's seminal work on Fixtures and Fittings (Period House Fixtures and Fittings 1300-1900, Countryside Books, 2005) identified 2 similar latches to the one shown right from Lime Tree Cottage in Hempnall. They were dated 1616 and 1649, but Linda has said the date range is probably wider. This house was dendro-dated to 1559, but the lock could be later.

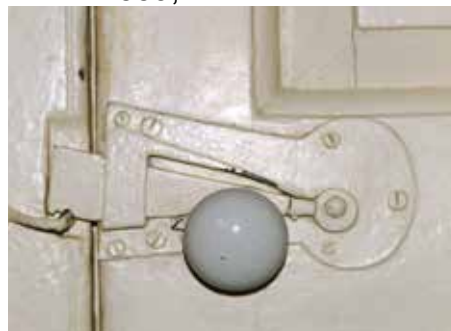
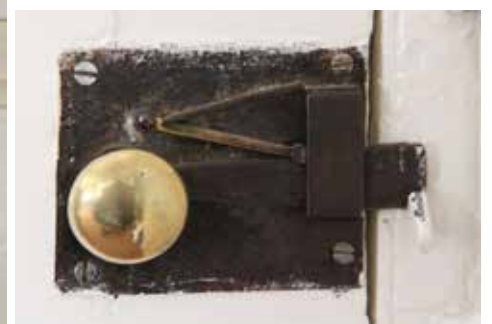
The sprung latch appears in Georgian times and two of the three different examples that were encountered in Hempnall are shown right.

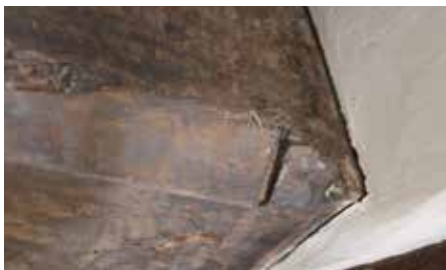
Stepped run-out stop (shield)

Used to terminate the chamfers along major timbers, particularly in ceilings. Attempts are being made to standardise the terminology in use by different researchers. The older NHBG reports used terms that are being superseded, so both are noted below - some examples from Norfolk:- (The commonly seen nick after the stop is usually dated after c1620)

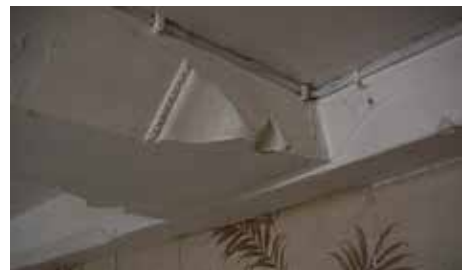
stepped runout with nick

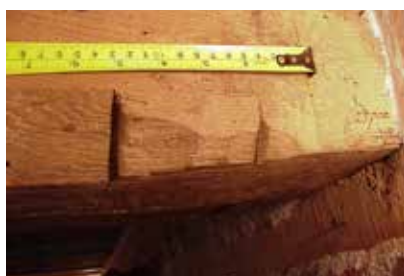
Scroll stop (lamb's tongue) with nick

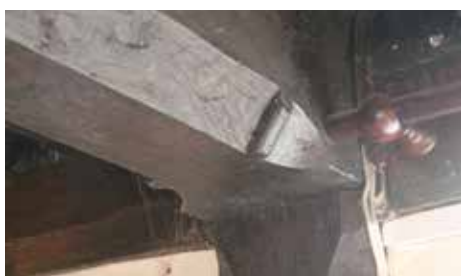
Run-out stop with bar

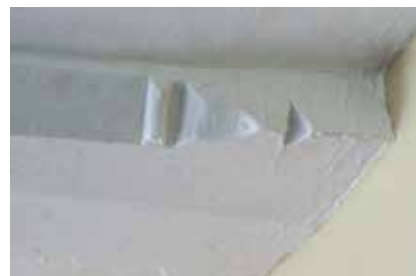
scroll stop with bar and nick

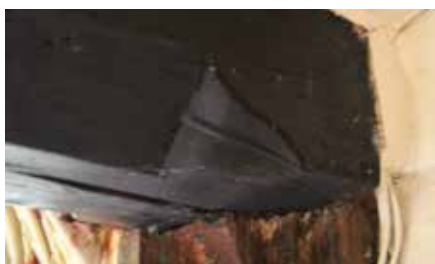
Leaf stop

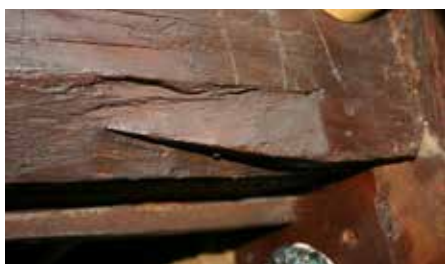
Broach stop

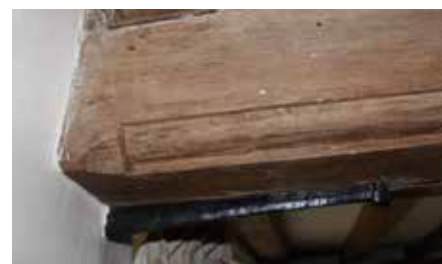
Sunk-quadrant chamfer with stepped run-out

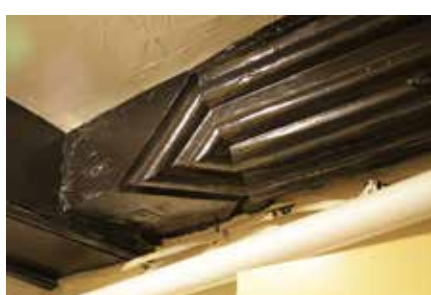
Roll-moulded joists

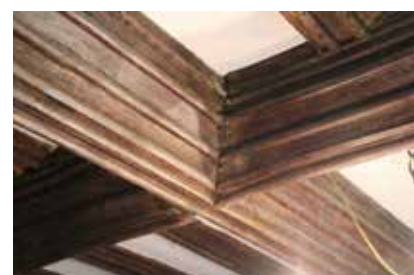
Roll-moulded joists

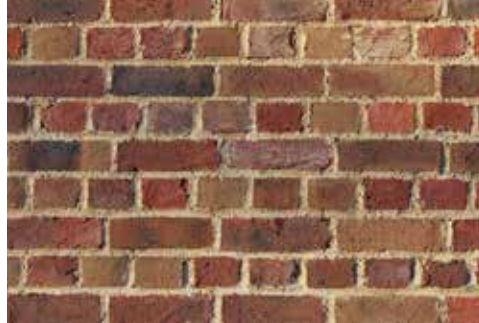
English bond - One course of headers (through the wall) and one course of stretchers (along the wall). Pre 1650, but used after, in places where strength is required

Bonding became standardised, with English Bond prevalent before 1650 and Flemish Bond becoming more frequently used after 1650. There are many variations of Flemish bond, some known by different names in different parts of the country

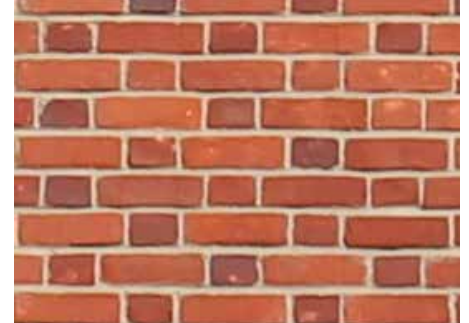
Flemish bond - almost always post 1650. Each brick has the opposite sort on every side, so headers and stretchers alternate, both horizontally and vertically

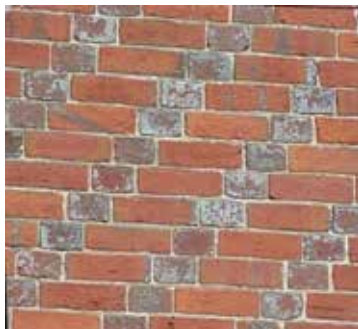
Still alternating headers and stretchers in each row, but the headers are placed above and below each other.

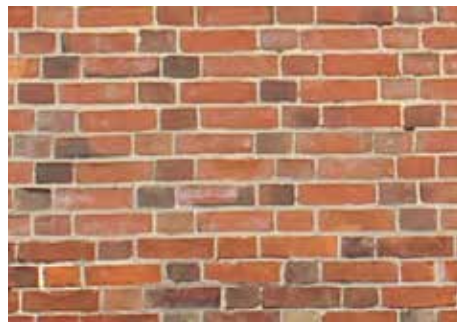
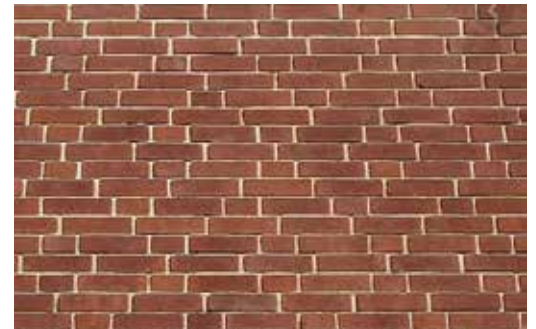
Diagonal Bond. A course of stretchers between each course which then forms a diamond pattern

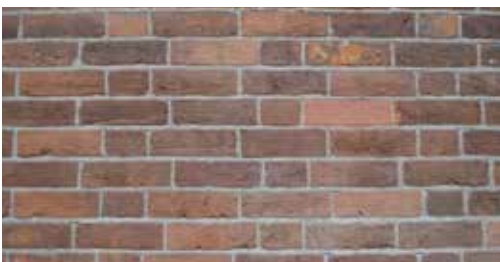
Flemish Garden Wall Bond - 3 stretchers, 1 header, 3 stretchers...

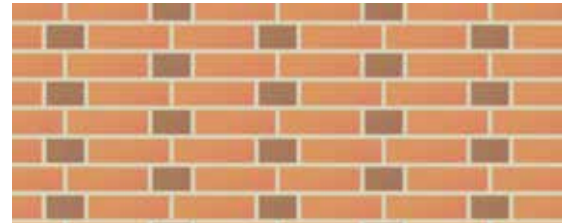
Monk Bond - 2 stretchers, 1 header, 2 stretchers...

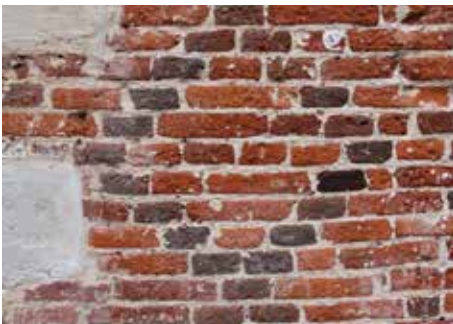
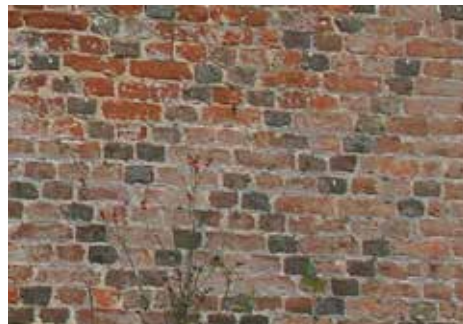
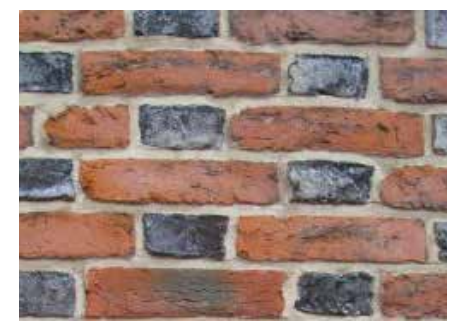
Decorative use of burnt bricks which were over-fired when bricks were often made in glorified bonfires rather than controlled kilns.

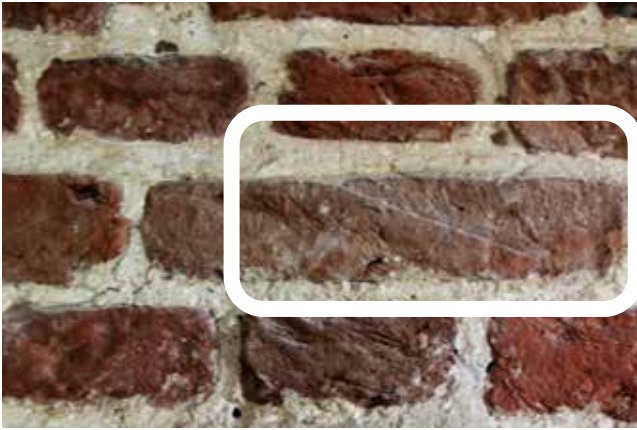
Bricks stacked in diagonal piles to dry, resulting in angled sagging between the bricks below

Once out of the mould, the bricks were left to dry in carefully stacked piles before firing.

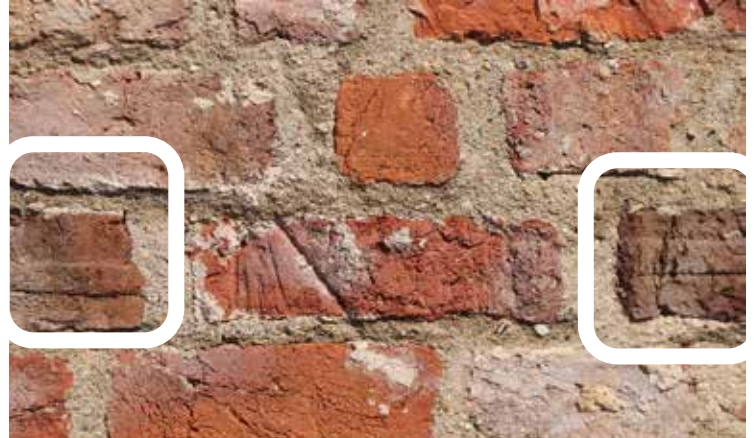
Bricks stacked in parallel piles to dry, resulting in straight sagging between the bricks below

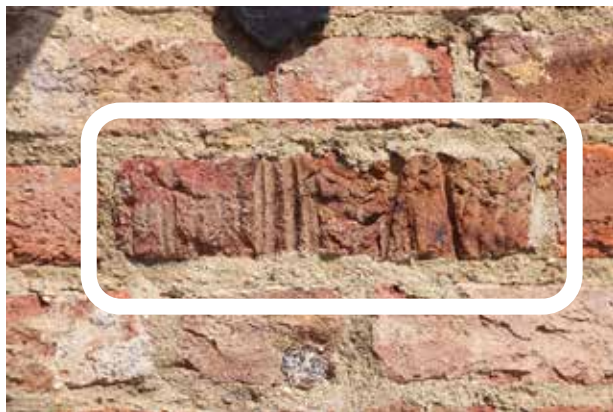
Probably the bottom row of the drying pile with impressions of straw

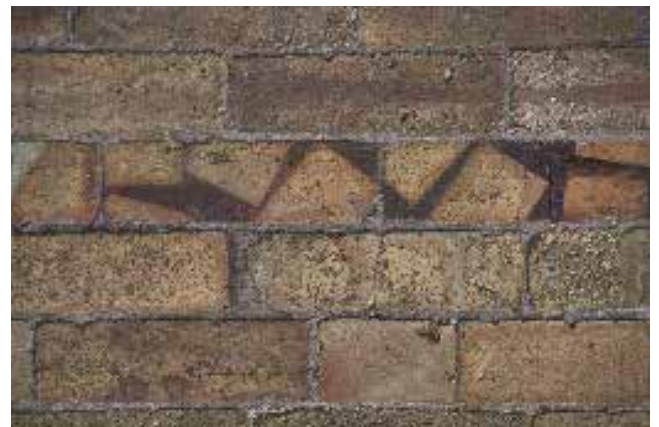
Even modern bricks overcook sometimes, leaving images of the bricks stacked above or below them in the kiln
